ISCORMA-4, Calgary, Alberta, Canada 27-30 August 2007

## High Speed Turbocharger Instability

Virginia Polytechnic Institute and State University  
Mechanical Engineering Dept. 0238, Blacksburg, VA 24061 USA

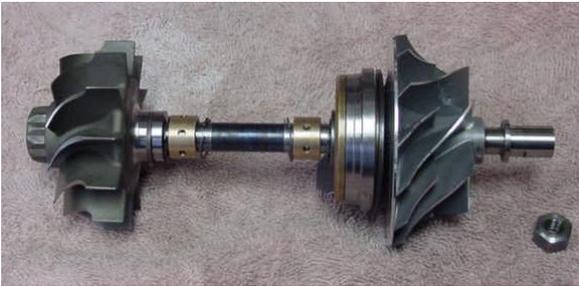
**Figure 1. A typical assembled turbocharger rotor**

An important factor in the design of an automotive turbocharger is the initial cost. The same power increase provided by the turbocharger can be provided by simply building a larger engine. Since engine weight is not a major part of overall weight for a diesel truck, the turbocharger is only competitive if it is less expensive than increasing engine size. For passenger cars the turbocharged diesel must compete with lighter and less expensive gasoline engines. To keep costs down while maintaining reliability, the designs of automotive turbochargers are usually as simple as possible. A common design assembly consists of a radial outflow compressor and a radial inflow turbine on a single shaft. Bearings are mounted inboard, with the compressor and turbine overhung as shown in Figure 1.

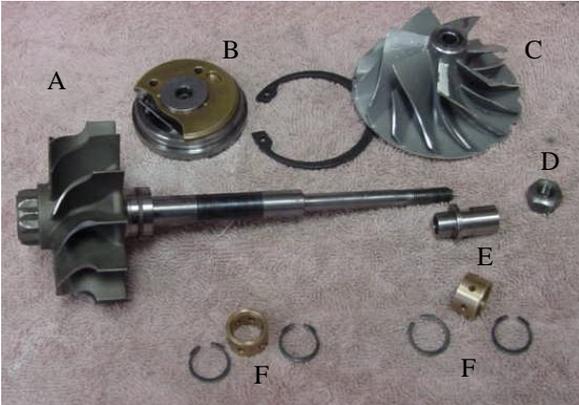
**Figure 2. Common turbcharger shaft components**

- A - turbine and shaft**
- B - thrust bearing assembly**
- C - compressor impeller**
- D - stock shaft nut**
- E - test nut and shaft probe target**
- F - floating ring bearing with retaining rings**

The compressor impeller in most turbochargers is made of aluminum (LM-16-WP or C-355T61). Aluminum (LM-27-M) is also used for the compressor casing, unless the compressor impeller is made from material other than aluminum. The turbine rotor sees operating temperatures of 750°C (1380°F) or more and must be of high strength so that thin airfoil sections can be used. A typical rotor material is 713C Inconel, a high nickel alloy. The turbine rotor casing also must withstand high temperatures, but strength requirements are lower. S.G. (spheroidal graphite) iron is used for operating temperatures up to 700°C (1290°F), high-silicon S.G. iron is used for temperatures up to 730°C (1350°F), and high nickel cast iron is used for higher temperatures. The shaft is usually made of high-carbon steel (C1144, EN 19C) to allow induction hardening of the journals. The turbine rotor in most common automotive turbochargers is connected to its shaft by a friction or electron beam welding method. The compressor wheel, or impeller, is usually a clearance or very light interference fit on the other end of the shaft. A locknut is used to hold the impeller against a shoulder on the shaft. Friction from the interference fit and/or nut clamping pressure is generally sufficient to transmit the torque, so no splines or keys are needed. Figure 2 shows the elements of a typical automotive turbocharger.

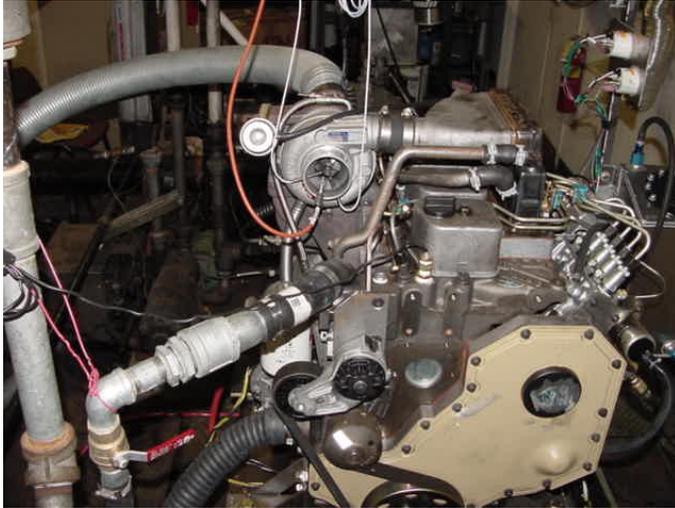
Figure 3. Diesel engine on test stand at Virginia Tech

The test turbocharger was installed on a 3.9 liter 130 HP 4 cylinder diesel engine. Design and setup of the test stand was performed by Mechanical Engineering senior students as an undergraduate design project [16]. The engine was installed, using its stock mounts, on a heavy cast-iron test base. It was coupled to a chassis dynamometer with a flywheel adapter plate and a shaft floating between two universal joints. The purpose of the dynamometer was to control turbocharger speed by controlling engine speed and load, not to measure engine performance. Fuel, coolant, exhaust, and control connections were made as needed. Figure 3 shows the engine on the Virginia Tech IC Engine Laboratory test stand.

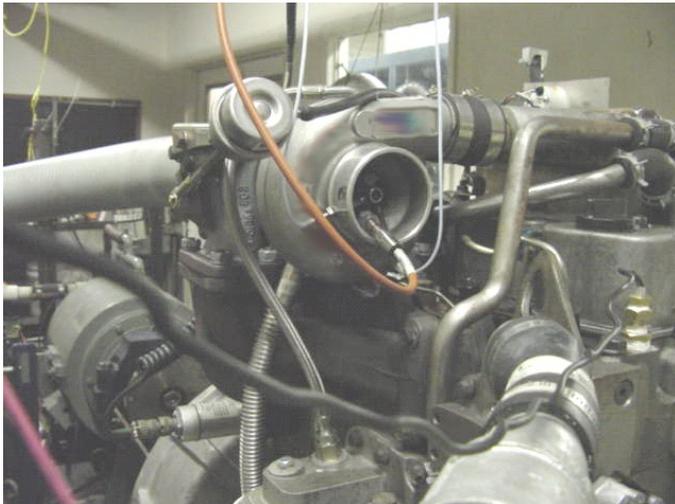
Figure 4. Compressor inlet with optical speed sensor

The basic engine instrumentation included engine rpm from an optical speed sensor monitoring the main shaft, coolant temperature gauge and a turbo boost gauge. Additional engine parameters can be monitored in future testing if desired. A second optical speed sensor and non-contact displacement probes were added to the turbocharger (see Figure 4). In addition, a velocity sensor was mounted on the side of the engine to document the basic engine vibration. The use of available instrumentation was helpful but special order equipment was also required to monitor this high frequency and small diameter shafting. In addition, the lighting for the optical speed sensor target is critical for proper speed detection.
