FAILURE ANALYSIS OF 2 LITER ENGINE TURBOCHARGERS

Edgar J. Gunter, PhD

ABSTRACT

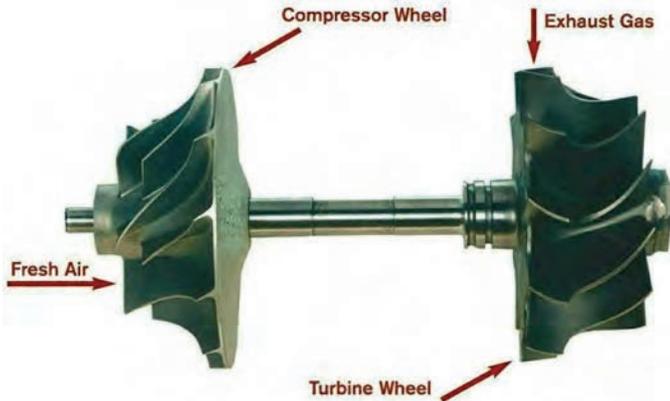
FIGURE 1 TYPICAL TURBOCHARGER DESIGN

In the standard turbocharger design, the compressor and turbine wheels are overhung. The turbine wheel is steel, while the compressor impeller is aluminum. This causes the system center of gravity to be closer to the turbine. It will be seen later that this will result in some unusual rotor dynamics which will cause more forces to be transmitted to the lightly loaded compressor bearing!

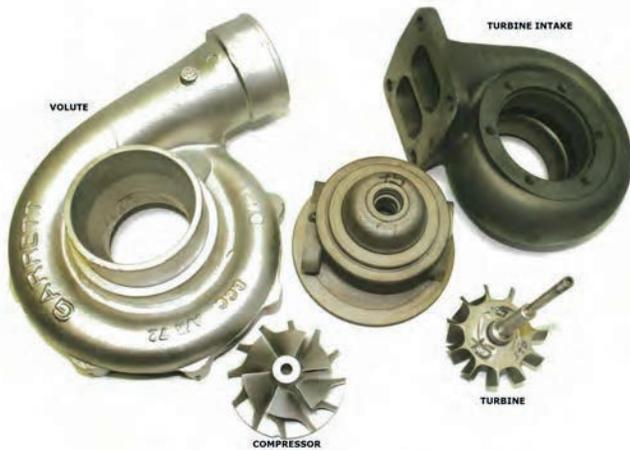
Figure 2 represents the turbocharger rotor components and turbine and compressor volute.

FIGURE 2 TYPICAL TURBOCHARGER COMPONENTS
(TURBO - Turbocharger Systems J. K. Miller 2008)

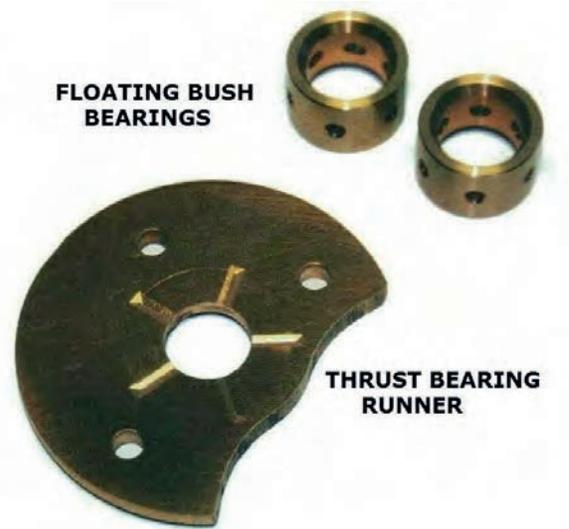
Figure 3 represents the typical float bush bearings and thrust runner used in the majority of most automotive turbochargers. The two bronze bearings are identical in design. The inner clearances of the bushings are kept tight, < 1mil (~ 0.02 mm) while the outer clearance are > 3 mils (~ 0.08 mm).

FIGURE 3 Typical Floating Bush and Thrust Runner
(TURBO J. K. Miller 2008)

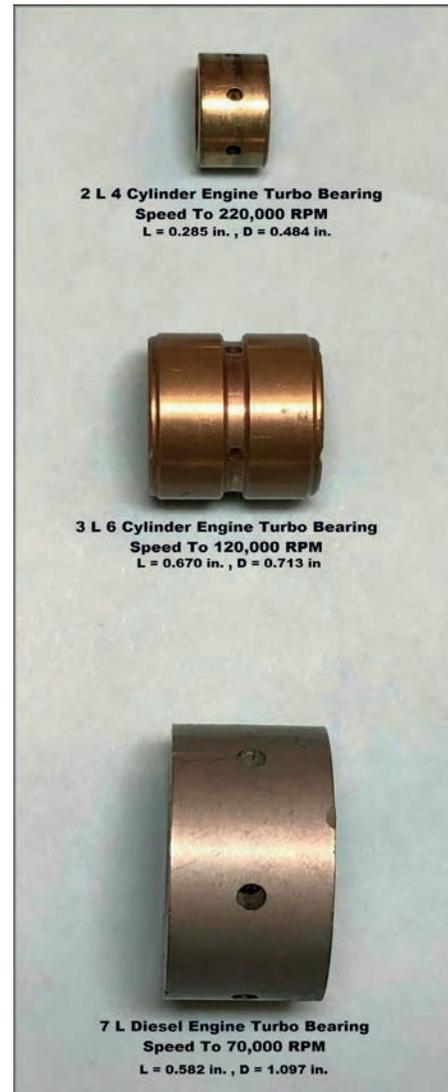
Figure 4 shows a comparison for three different types of floating bush bearings. The top figure is the floating bush bearing for the four cylinder 2 L engines. This small bearing only has a diameter of 0.484 in.(12.3 mm) with a length of 0.285 in.(7.2mm). Since these turbochargers operated at speeds of over 200,000 RPM, it is estimated that the ring rotates at a speed of around 50,000 RPM. Lubrication is very difficult for these bearings. The second figure represents the floating bush bearing for a 6 cylinder engine and the last figure represents the bearing for a 7 L diesel.

Figure 4 Comparison of Floating Bush Bearings For 2 , 3 and 7 Liter Engines

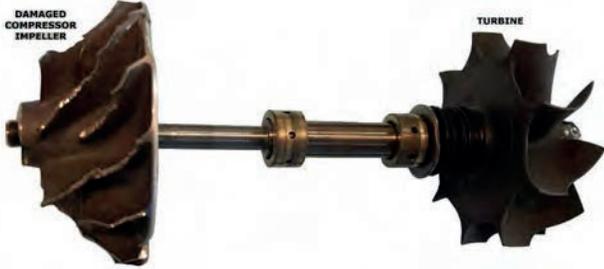
Figure 5 represents a turbocharger with a damaged compressor impeller. Extensive wear marks may be observed on both the compressor and turbine end bearings. In particular the turbine end bearing shows a distinct narrow wear band due to sub synchronous whirling in the conical mode.

FIGURE 5 VIEW OF 2 L TURBOCHARGER WITH DAMAGED COMPRESSOR WHEEL AND WORN BUSHINGS

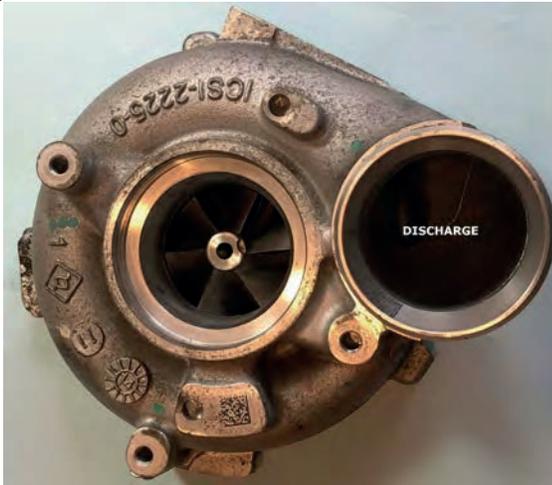
Figure 6 shows the turbo compressor inlet and air discharge passages.

FIG. 6 COMPRESSOR INLET AND DISCHARGE

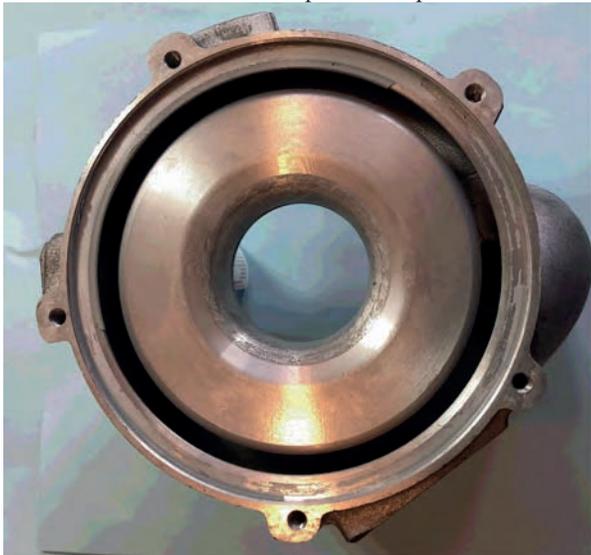
Figure 7 represents the compressor volute showing large rub marks from contact with the compressor impeller.

FIGURE 7 VOLUTE SHOWING HEAVY RUB MARKS

In order to maximize the efficiency of an open bladed centrifugal impeller, the clearance space between the impeller and volute is kept as close as possible to minimize leakage. As the compressor bearing wears over time due to inadequate lubrication, the compressor bearing clearance will open up. The predominant unstable mode of the turbocharger is a conical whirl mode. Hence the small increases in compressor bearing clearance allow the impeller wheel to contact the volute causing blade damage.. The drop in efficiency then requires the turbocharger to be replaced.

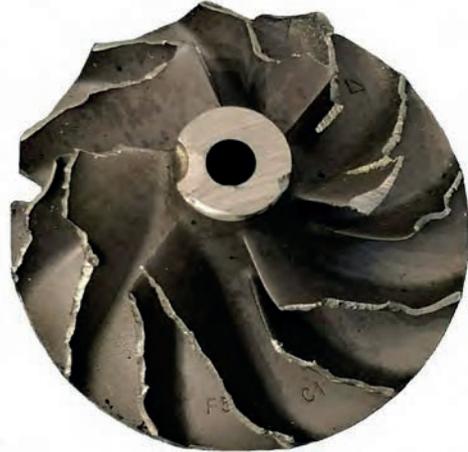
Figure 8 represents a damaged compressor impeller due to contact with the volute.

FIGURE 8 DAMAGED COMPRESSOR

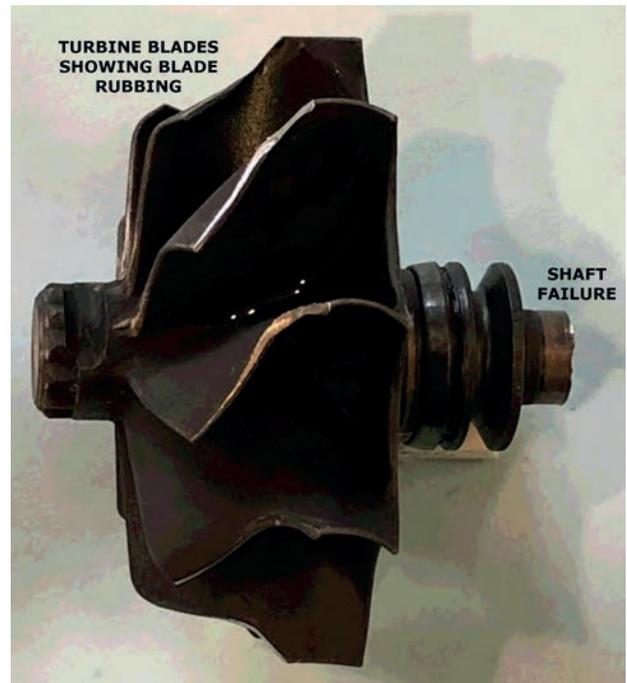
If the compressor impeller experiences a hard rub against the volute, the friction torque will cause the turbine to experience a torsional shaft failure at the turbine hub as shown in Figure 9.

FIGURE 9 TORSIONAL SHAFT FAILURE AT TURBINE HUB DUE TO COMPRESSOR RUB

In all of the failed turbochargers examined, the compressor end bearings showed extensive scoring and bearing clearance enlargement. As previously mentioned, the turbocharger floating bush bearing inner clearance is kept very tight in order to control rotor motion. Once the bearing inner clearance tends to wear and open up, the turbocharger is subjected to large subsynchronous conical whirl motion which can cause contacting of the compressor impeller on the volute surface. This results in either damage to the compressor vanes as shown in Figure 8, or to catastrophic turbine shaft failure as shown in Figure 9.

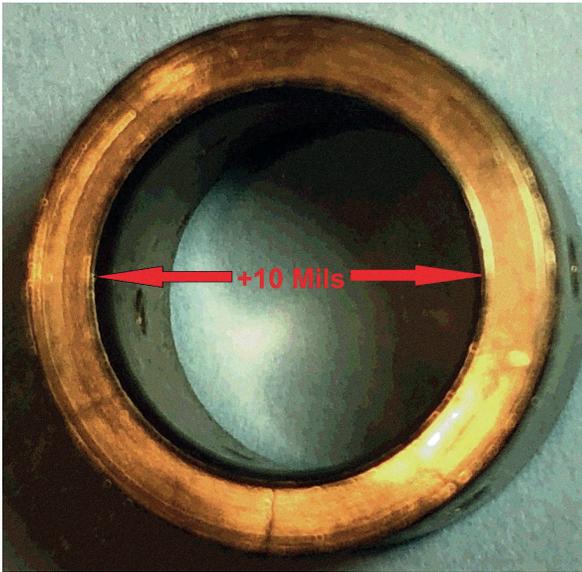
Figure 10 shows the compressor end bearing in which the internal bearing clearance has been expanded to over 10 mils (0.25 mm) from the original specified design clearance.

FIGURE 10 COMPRESSOR BEARING WITH ENLARGED BEARING CLEARANCE

It is seen in Figure 31, that an increase of clearance from 1 to 2 mils now causes the rotor to operate in almost 90% of the bearing clearance. It was previously mentioned and shown in Figure 10 that one failed turbocharger compressor bearing had the internal clearance enlarged to over 10 mils.

One of the concerns with the design of these turbochargers is to minimize turbocharger lag. It is therefore desirable to keep the bearing friction losses to a minimum. In the examination of all failed 2 L engine turbochargers, significant wear was observed in the compressor end bearing clearance. Basically the compressor end bearing is overloaded and under lubricated. To improve turbocharger reliability, the compressor end bearing, in particular, must be redesigned for improved lubrication and stability.

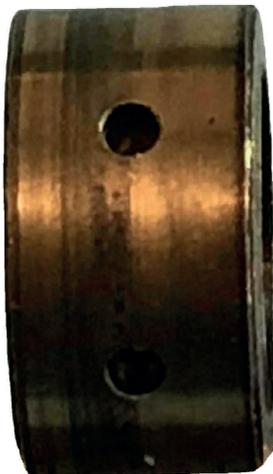
Figure 11 represents a side view of one of the compressor end floating bush bearings from one of the failed turbochargers. All of the compressor end bearings of the failed turbochargers showed evidence of heavy rub marks.

FIG. 11 COMPRESSOR BEARING SIDE VIEW

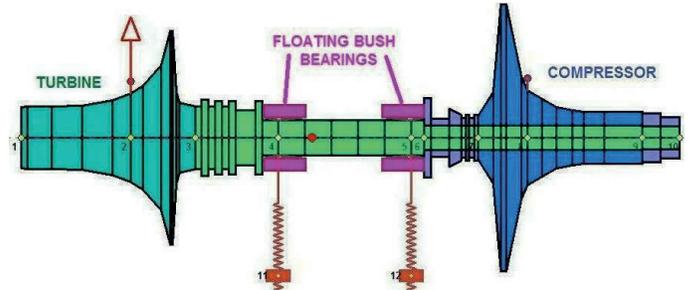
In order to understand the dynamical behavior of the double overhung turbocharger in which the turbine wheel is substantially heavier than the compressor impeller, it is necessary to first start with the basic critical speed analysis of the system to understand the critical speed mode shapes and energy distribution of the bearings and shaft. Figure 12 represents a computer model of the 2 L engine turbocharger mounted in floating bush bearings. In the first phase of the analysis for the fundamental critical speeds of the system, the bearings are simply treated as linear springs. Later more advanced analysis is performed computing the bearing inner and outer film stiffness and damping coefficients and finally a nonlinear transient analysis with unbalance and Alford forces acting on the impeller wheels is computed.

Figure 12 Turbocharger Computer Model with Floating Bush Bearings

As seen in Figure 12 for the turbocharger, the system mass center is very close to the turbine end bearing. As a result, during the second mode, the heavier turbine motion is reduced and larger amplitudes of motion are observed at the compressor end as shown in Figure 14. This explains in part why more damage is always observed on the compressor end bearings. It is the compressor end bearing that requires the larger bearing as compared to the turbine end. At speeds above the second critical speed, larger forces are transmitted to the compressor bearing. However, with all turbochargers with floating bush bearings, the bearings are always identical.

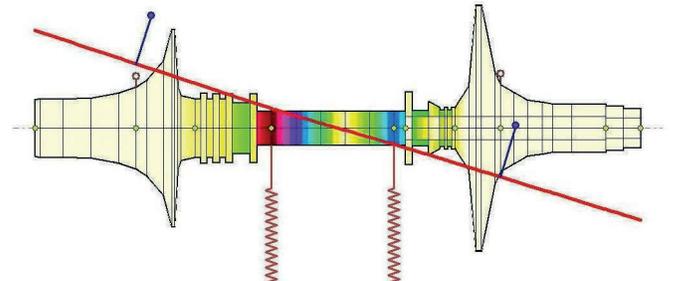
Figure 13 represents the turbocharger first critical speed. With double overhung rotor designs, the first critical speed is a conical mode in which the turbine and compressor are moving out of phase. All the strain energy is in the bearings and there is very little shaft bending occurring in the first mode.

Figure 13 First Turbocharger Critical Speed

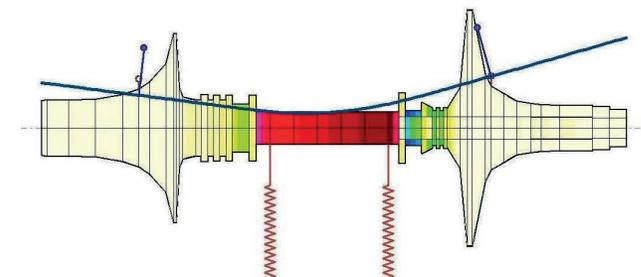
Figure 14 represents the second rotor critical speed. In this mode, the turbine and compressor are in phase. What is unusual with this second critical speed and that there is a considerable amount of bending at the shaft center.

Figure 14 Second Turbocharger Critical Speed

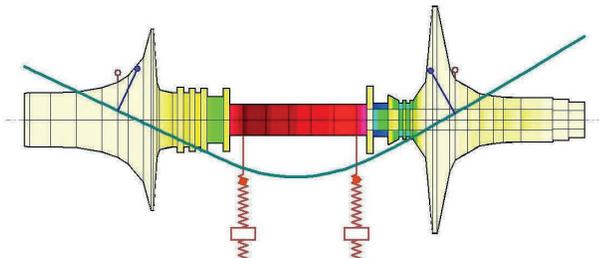
Figure 15 represents the third critical speed which is essentially a free-free bending mode. This frequency is predicted to occur at 129,000 RPM. In all turbochargers of previous generations, the third bending critical speed has always been above the running speed. The occurrence of the third bending critical speed for double overhung rotor, in the operating speed range, is highly undesirable. This third bending critical speed occurs in the operating speed range because of the extremely slender shaft used in this design in order to reduce friction losses and minimize turbocharger lag.

Figure 15 Third Turbocharger Bending Critical Speed at 129,000 RPM

There is another significant concern and that is the very thin shaft connecting the turbine and compressor is such that it allows the third bending critical speed to be in the operating speed range. The torsional critical speed is also at a similar speed to the third bending critical speed. This is an undesirable feature as passing through the third bending critical speed causes additional loading and wear, particularly on the compressor end bearing.

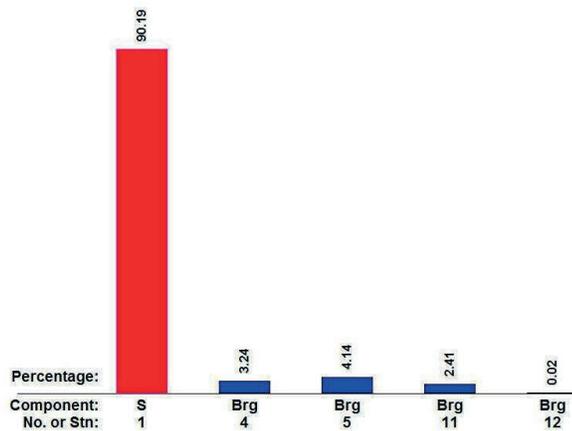
The reason that it is undesirable to have the third bending mode occur within the operating speed range is that the bearings provide little damping to control this mode. The majority of the system strain energy resides in the shaft. Figure 16 shows the distribution of the strain energy of bending and of the bearings for this particular mode. As can be seen from Figure 16, over 90% of the system strain energy resides in shaft bending. This is a totally unacceptable situation.

Figure 16 Shaft and Bearing Strain Energy Distribution For the Third Rotor Critical Speed- N = 129,000 RPM

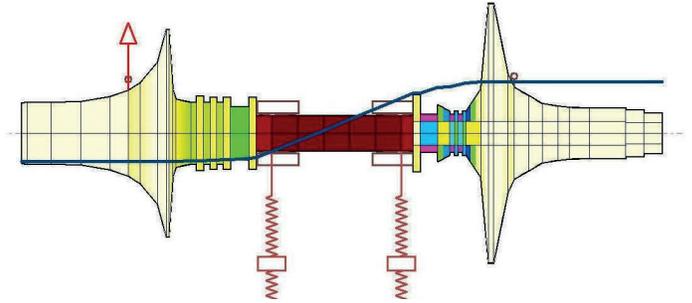
Figure 17 Turbocharger First Torsional Mode at 131,108 RPM

Figure 17 represents the turbocharger first torsional mode. The first torsional mode is computed to be at a speed of 131,108 RPM. This speed is well within the operating speed range of the turbocharger. Normally for turbochargers, the third bending critical speed and the torsional critical speed both are well above the operating speed range of the turbocharger. It is extremely unusual and highly undesirable to have both the 3rd bending critical speed and the turbocharger 1st torsional critical speed to be not only be in the operating speed range, but to closely coincide. This is a highly undesirable situation.

Unlike diesel engines for trucking applications, automotive turbochargers operate over a wide speed range. The turbocharger run up and run down through the 120,000 to 130,000 RPM speed range could cause additional wear and degradation to the compressor end bearing.

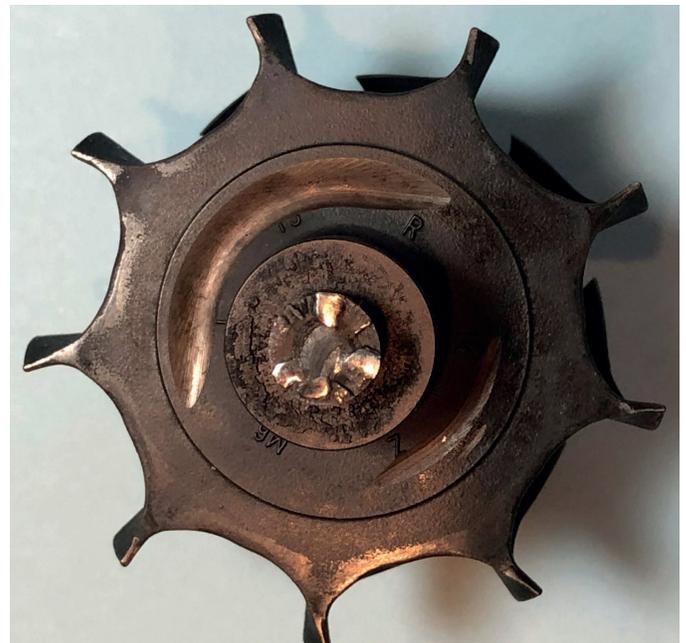
Figure 18 Backside of the Turbine Wheel Showing Torsional Shaft Failure and Extreme Balancing Corrections

Figure 18 represents the backside of the failed turbine wheel. It is apparent that the shaft failure is a torsional failure. This type of failure is initiated by heavy rub the contact of the compressor impeller on the volute. Of particular concern with the turbine wheel is extreme balancing corrections that have been applied to

the turbine wheel. Turbochargers in general employ a two plane balancing procedure. With normal turbochargers, the first two critical speed modes are rigid body conical and cylindrical modes. The third bending critical speed is usually well above the running speed. Hence two plane balancing will properly a turbocharger for unbalance response throughout the speed range.

The situation is considerably different if the third bending critical speed lies within the speed range. Two plane balancing will not be able to correct the unbalance response if the rotor is operating in the third critical speed bending mode. With the heavy balance corrections shown on the turbine wheel, the turbocharger will be highly unbalanced and will excite the third bending mode at around 120,000 RPM. In addition, this mode will have a high amplification factor because 90% of the strain energy of the system is in shaft bending and very little energy is in the bearings to help dampen this particular critical speed response. Hence additional bearing damage may occur during run up and run down of these high-speed turbochargers when passing through the 3rd critical speed in the range of 120,000 to 130,000 RPM.

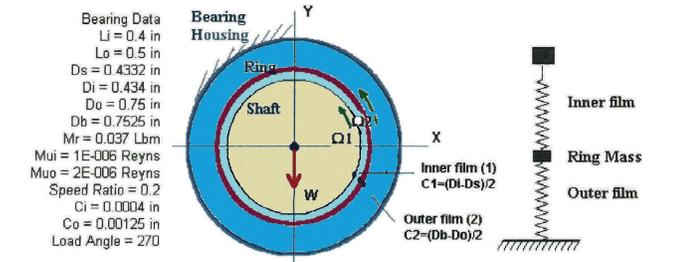
Figure 19 represents the characteristics of the floating bush bearing. To compute the fluid film bearing characteristics generated by the inner and outer films of the floating bush bearing a number of assumptions for the floating bush bearing must be made. These assumptions are concerned with the inner and outer bearing clearances film viscosities and ring rotational speed.

Figure 19 Floating Bush Bearing

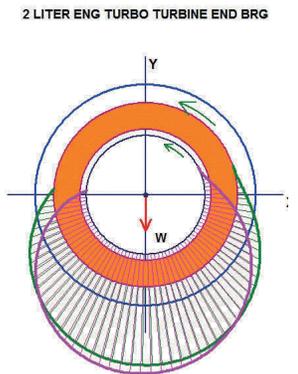
Bearing Data
 $L_i, L_o = 0.2785, 0.2785$ in
 $D_s, D_i = 0.3125, 0.3135$ in
 $D_o, D_b = 0.4845, 0.4875$ in
 $C_i, C_o = 0.00050, 0.00150$ in
 $C_o/C_i = 3$
 $M_r = 0.007$ Lbm
 $\mu_{i1} = 9E-07$ Reyns
 $\mu_{o1} = 1E-06$ Reyns
 $Speed\ Ratio = 0.25$
 $Load = 0.2$ Lb
 Rotor RPM = 220000 rpm
 $e_j/(C_i + C_o) = 0.0164$
 $h_{min} = 0.50, 1.47$ mils
 $P_{max} = 4.26, 2.79$ psi
 $Loss = 0.5861$ hp
 $K_{ixx,xy} = 1.34E+04, 1.71E+05$ Lbf/in
 $K_{iyx,yy} = -2.40E+05, 1.22E+04$ Lbf/in
 $C_{ixx,xy} = 1.19E+01, -9.05E-01$ Lbf-s/in
 $C_{iyx,yy} = -9.05E-01, 1.67E+01$ Lbf-s/in
 $K_{oxx,xy} = 4.53E+02, 4.98E+03$ Lbf/in
 $K_{oyx,yy} = -6.29E+03, 1.43E+01$ Lbf/in
 $C_{oxx,xy} = 1.73E+00, -1.06E-01$ Lbf-s/in
 $C_{oyx,yy} = -1.06E-01, 2.19E+00$ Lbf-s/in

Figure 20 Floating Bush Bearing Stiffness and Damping Coefficients

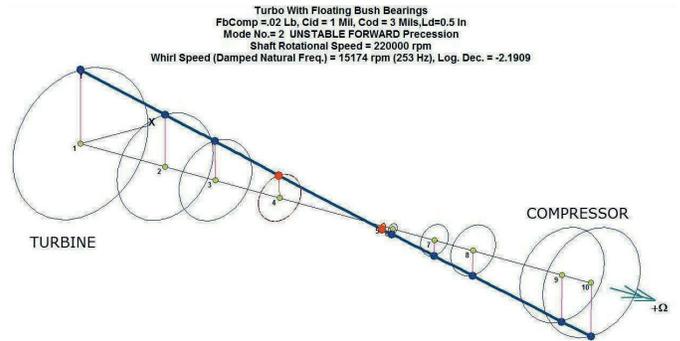
Figure 21 represents the first computed unstable turbocharger mode at a speed of 220,000 RPM. This mode is a conical whirl mode predicted to be at a frequency of 15,074 CPM. In this mode it is observed that the turbine and the compressor exhibit conical motion whirl in which the impellers are out of phase to each other.

Figure 21 Turbocharger 1st Unstable Conical Whirl Mode At 220,000 RPM, Nf1 = 15,174 CPM, Log Dec = -2.2

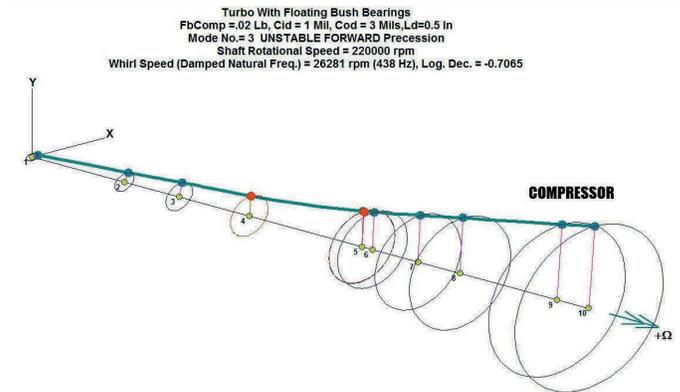
Figure 22 shows the second unstable turbocharger mode. In this mode, the compressor and turbine are in phase. In the excitation of the second unstable mode, the heavier turbine wheel maintains a fairly small amplitude while large amplitudes of motion are generated at the compressor impeller. As previously mentioned, all examined compressor bearings for the various failed turbochargers showed considerable enlargement of the compressor end bearing inner clearance.

Figure 22 Turbocharger 2nd Unstable Whirl Mode At 220,000 RPM, Nf2 = 26,281 CPM, Log Dec = -0.71

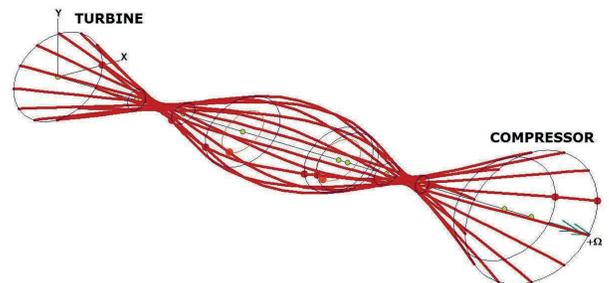
Figure 23 3rd Bending Forward Mode at 135,453 RPM

Figure 23 shows the third mode, which is a shaft bending mode, which is undesirable to have in the operating speed range.

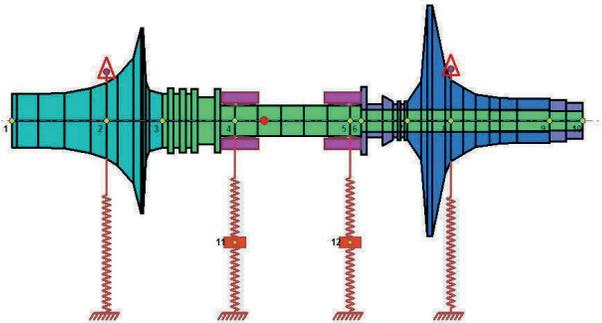
When the turbocharger is operating under high power levels, there are additional forces acting on the turbine and compressor referred to as the Alford forces. These forces are simulated by assuming a bearing location at the turbine and compressor locations and adding bearing cross coupling components. Unbalance components are also assumed to be acting on both the turbine and compressor locations. In addition, gravitational effects are also included.

Figure 24 Turbocharger Unbalance and Alford Forces Acting on the Turbine and Compressor

The turbocharger as shown in Figure 24 has 12 master elements. The total number of degrees of freedom for the turbocharger is 44. In addition to the equations of motion for the rotor system, at each time step, the Reynolds equation for the pressure profiles of the inner and outer rings of the floating bush bearings must be computed. These pressure profiles are then numerically integrated to determine the forces acting on the floating bush and shaft. A Wilson Theta method of numerical analysis was chosen with 500 steps per cycle for 50 cycles of shaft motion.

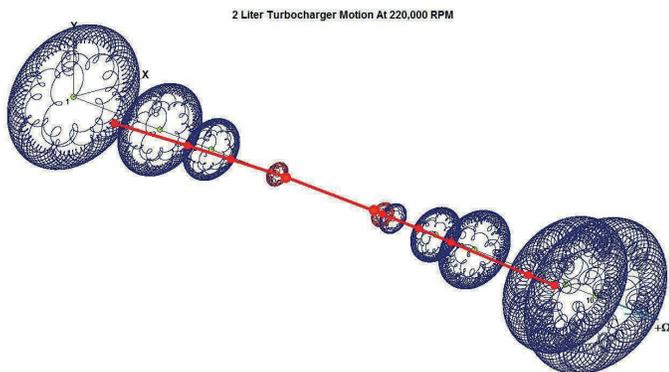
Figure 25 Time Transient Analysis of Turbocharger at 220,000 RPM With Impeller Unbalance and the Alford forces

If a hard rub on the casing is encountered from the conical motion of the impeller, then the gyroscopic moment will act to cause the impeller to precess backwards. When this occurs, the drive torque on the turbine causes the shaft to shear off at the hub turbine, as seen in Figures 9 and 18. This type of failure often occurs when the turbocharger is operating under high power levels, such as accelerating up an incline. The additional Alford forces acting on the impellers causes a high amplitude subsynchronous conical whirl motion as shown in Figure 25. This motion also creates an audible sound.

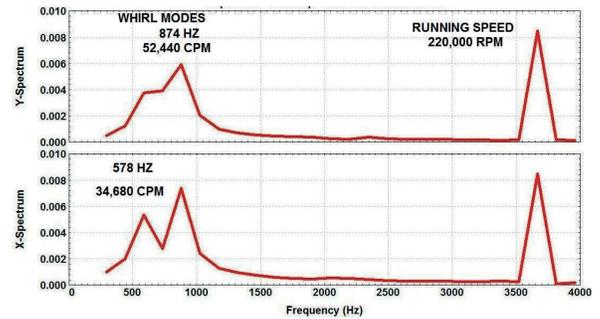
Figure 26 represents an FFT spectrum analysis of the nonlinear time transient motion of the turbine at station 1 at 220,000 RPM. The complex motion is composed of synchronous motion due to the effect of unbalance and the excitation of the lower system modes. It is also apparent that both the first and second turbocharger critical speeds may be excited by the Alford forces acting on the turbine and compressor.

Figure 26 FFT Spectrum Analysis of Turbine Motion

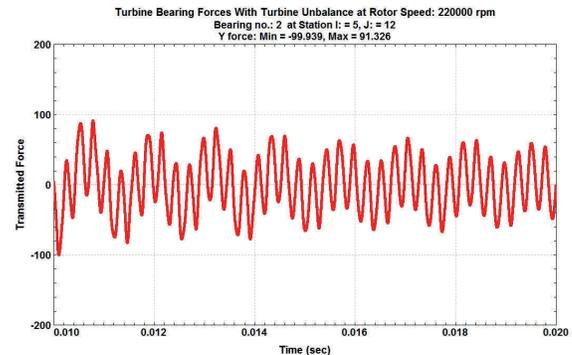
Figure 27 Turbine Bearing Forces Transmitted With Turbine Unbalance

Fig 27 represents the turbine bearing force transmitted with 0.001 oz-in of the turbine wheel unbalance. The maximum forces transmitted is shown to be approximately 90 pounds. Observation of the various failed turbochargers showed that the turbine wheels often had heavy unbalance corrections applied to the wheels.

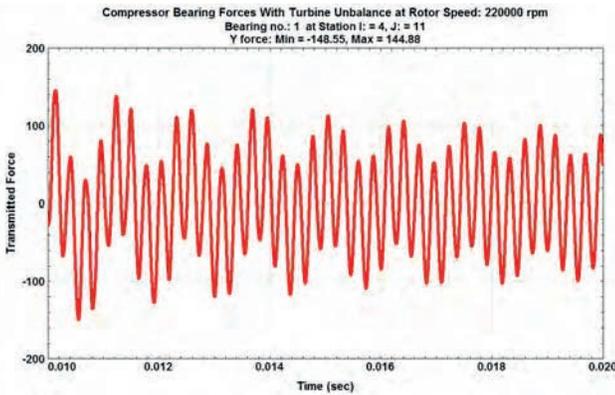
Figure 28 represents the forces transmitted to the compressor end bearing with unbalance applied at the turbine wheel. It is of interest to note that the maximum force transmitted to the compressor bearing is 150 pounds, which is over 50% higher than the bearing forces transmitted to the turbine bearing. This seems to defy intuition that unbalance place near the turbine bearing

would cause higher forces to be transmitted to the compressor bearing. The reason for this is due to the dynamical characteristics of the turbocharger in which the turbine wheel is substantially heavier than the aluminum compressor impeller. After the rotor pass through the first critical speed which is a conical mode, the heavier turbine wheel forms a very stationary node point and causes higher amplitudes of motion to occur at the compressor bearing.

This helps to explain why the compressor bearing wear is always substantially greater than what has been observed with the turbine bearings. After passing through the first critical speed, the turbocharger amplitudes of motion are always higher at the compressor location as shown in Fig. 22.

Figure 28 Compressor Bearing Forces Transmitted With Turbine Unbalance

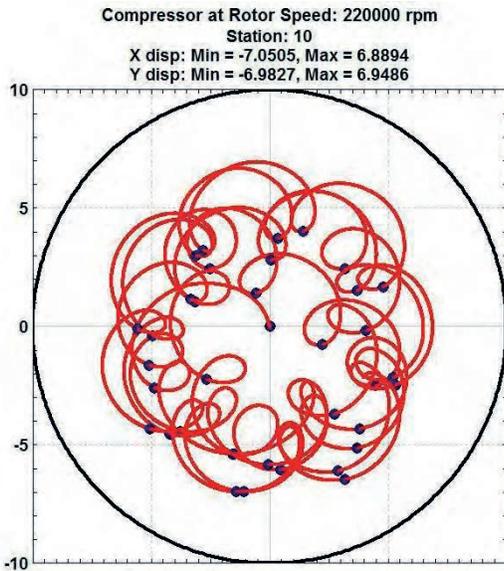
Figure 29 Shaft Motion with One Mil Cd

Figure 29 represents the compressor bearing shaft motion with one

mil (0.25 mm) diametrical clearance. The orbital motion combines the non-synchronous whirling in the synchronous motion due to the small amount of unbalance at the turbine wheel. Note that the total orbit fills up 70% of the bearing clearance.

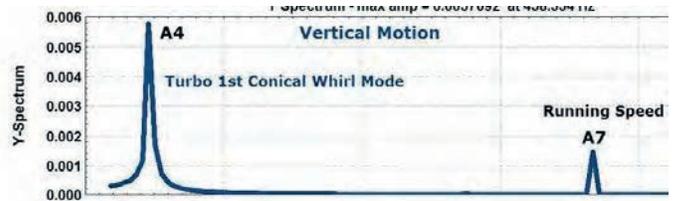
Figure 30 Spectrum of Compressor Bearing Motion Showing Strong Excitation of the Turbocharger First Critical Speed

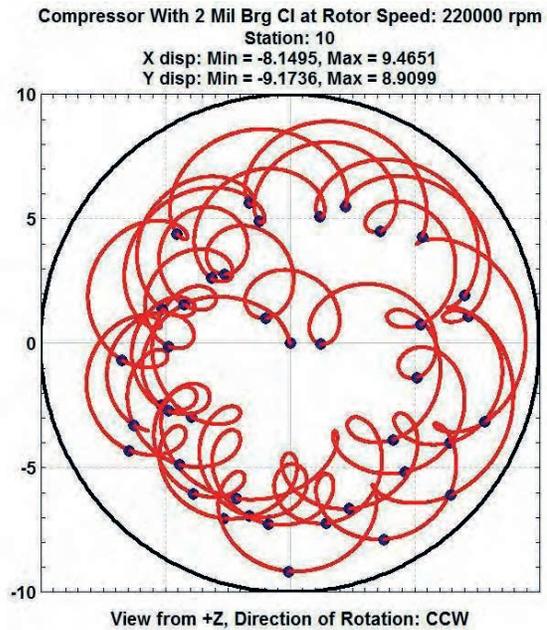
Figure 31 Shaft Motion with Two Mils Cd

Figure 31 represents the shaft motion in the compressor bearing with the clearance increase from 1 to 2 mils (0.05 mm). In order to maintain control of the turbocharger, the compressor inner bearing clearance must be kept extremely tight. As previously mentioned, all turbochargers with floating bush bearings are unstable and will excite the lower system modes. In order to operate, the turbocharger must rely on the nonlinear bearing forces in order to generate controlled limit cycle motion.
