## Review and Failure Analysis of Three 4 Cylinder Engine Turbochargers *And Methods on How to Extend Turbocharger Life*

Edgar J. Gunter, PhD

# 2 Liter Engine Turbocharger Failure Analysis

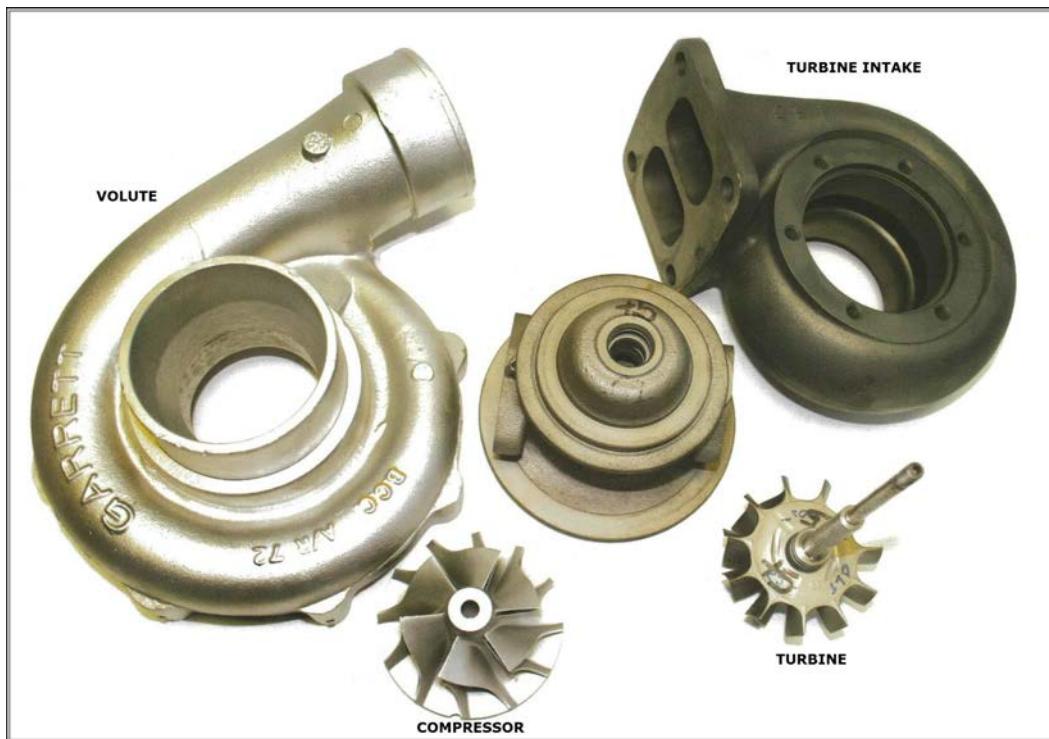
**Fig. 1.1 Typical Turbocharger Components**  
*(TURBO - Turbocharger Systems J. K. Miller 2008)*

The basic components of the turbocharger are shown in the above figure by J. K. Miller in his practical applied book on turbocharger performance. Not shown in this figure is the wastegate that controls the volume of exhaust gas into the turbine section of the turbocharger. The main engineering effort of the turbocharger manufacturers however rests in the efficient design of the compressor and turbine wheels.

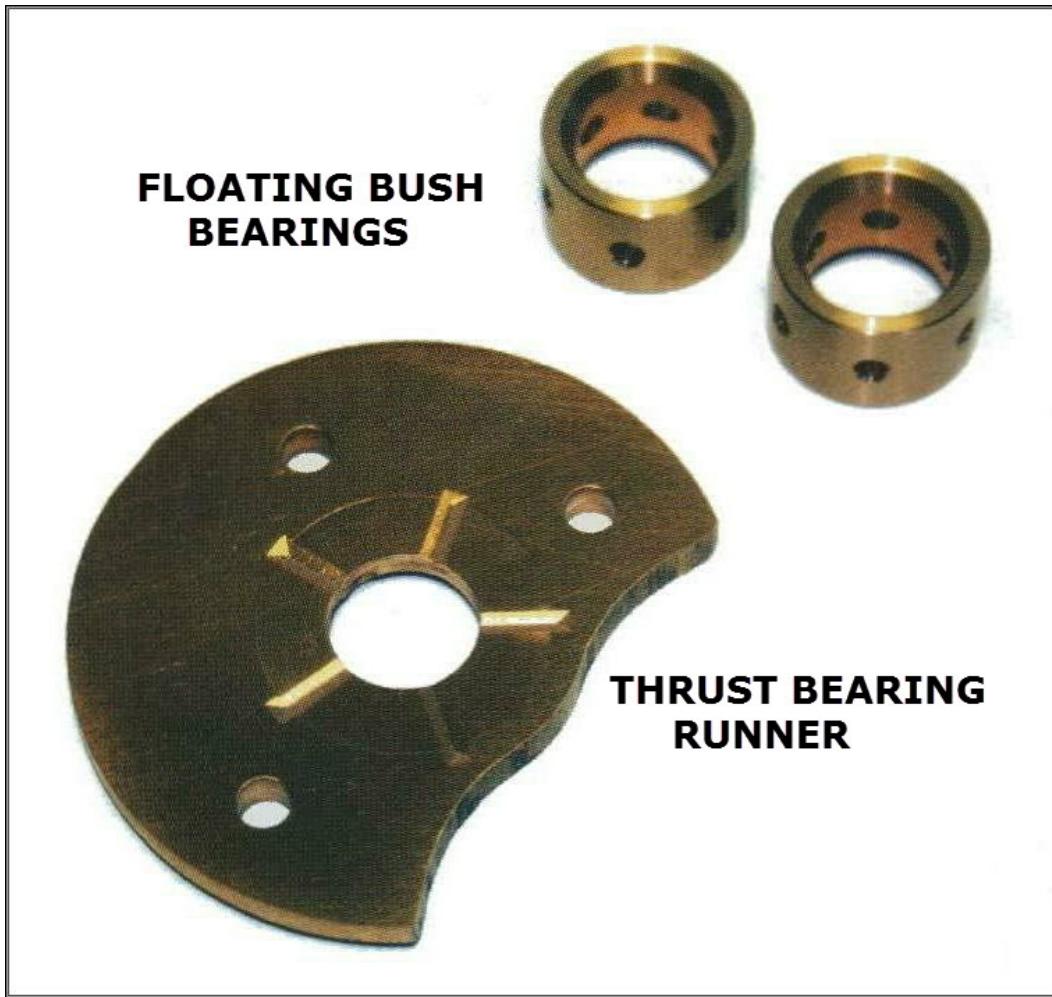
**Fig. 1.2 Typical Turbocharger Floating Bush Bearings and Thrust Runner**  
*(TURBO - Turbocharger Systems J. K. Miller 2008)*

Figure 1.2 represents the typical floating bush bearings and thrust runner used in most automobile turbochargers. The bronze bushing bearings are the most common bearing type used in automobile turbochargers. These bearings are inexpensive and easy to fabricate. They are installed to freely rotate on the shaft.

The bearing design is such that the inner bearing to shaft clearance is very tight and the outer clearance between the bearing and the casing is more generous. The clearance ratio averages about three times the inner bearing clearance. The rotation of the high-speed shaft causes the ring to rotate about 20 to 25% of the shaft speed. This creates an external bearing which generates additional stiffness and damping coefficients acting on the bearing ring.

Figure 1.4 represents a schematic diagram of a turbocharger. The causes of turbocharger failures are not well understood in the industry. As an example in this figure, it assumes that foreign objects ingested into the turbine or compressor are one of the main causes of turbocharger failure. The main cause of turbocharger failure is the use of the inexpensive bronze floating bush bearings as shown in Figure 1.2.

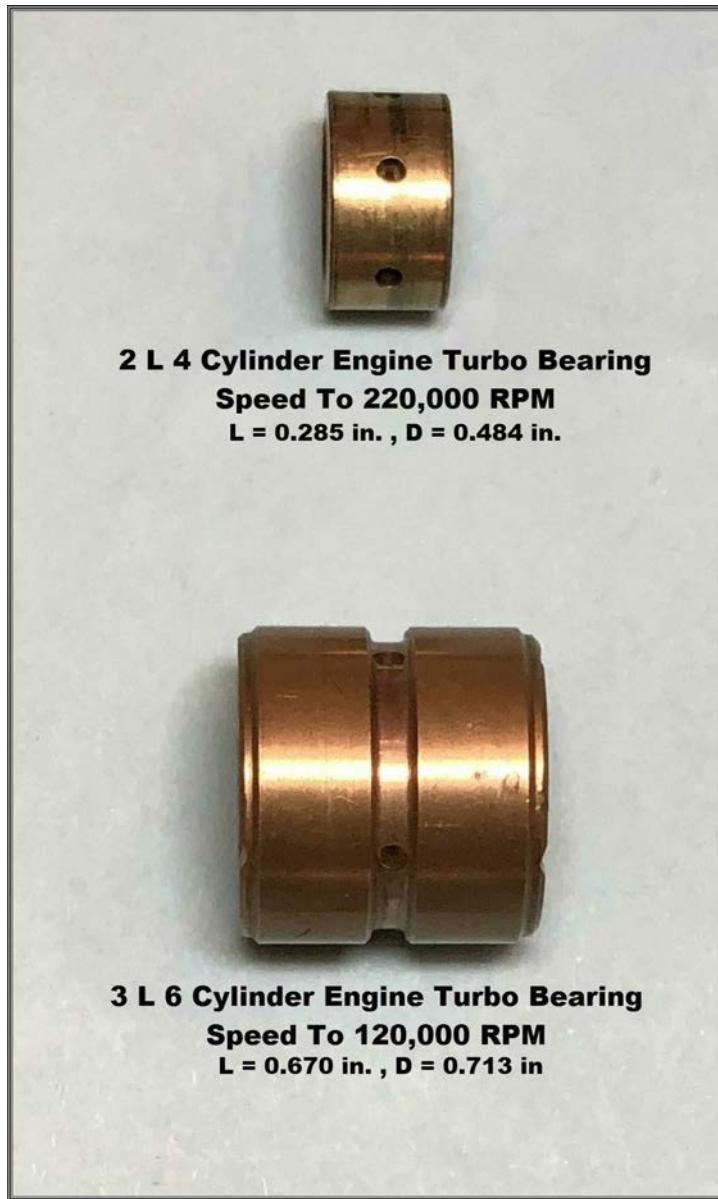
**Fig. 1.3 Comparison of 2 L 4 Cylinder Engine Bearing to 3 L Diesel Engine Bearing**

Figure 1.3 shows a comparison of the small 2 L floating bush bearing in comparison to the larger 3 L diesel engine bearing. The diesel engine runs at a much slower speed and as can be seen has a much more generous bearing. Note also in the case of the diesel engine floating bush bearing, that there is a central groove in order to ensure that sufficient oil is fed to the inner bearing surface.

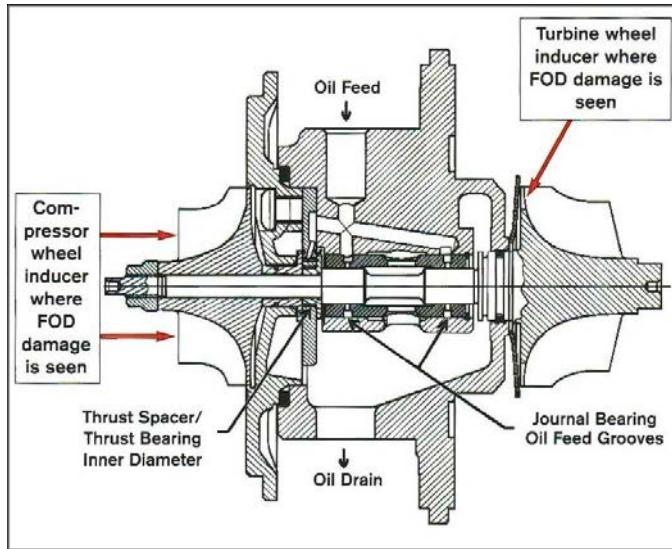
**Fig. 1.4 Turbocharger Cross Section**  
(TURBO - Turbocharger Systems J. K. Miller 2008)

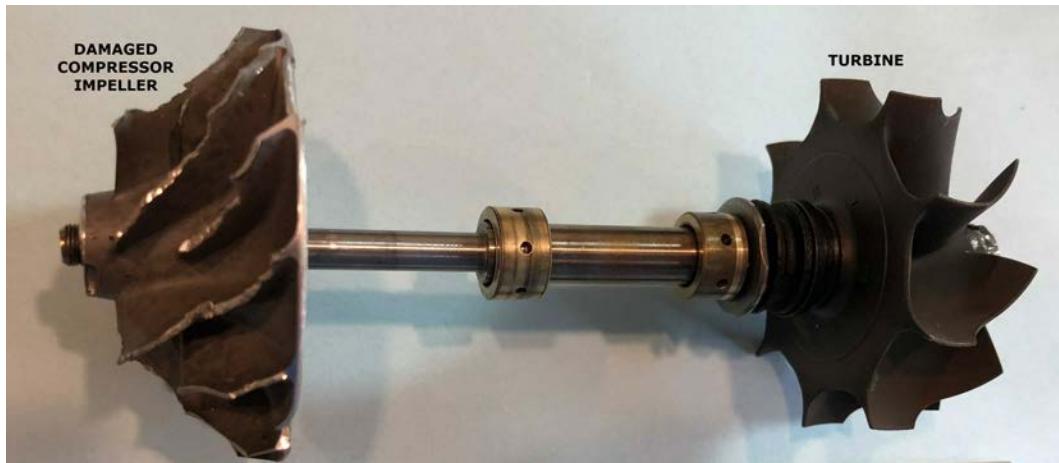
**Fig. 2.1 View of 2 L Turbocharger With Damaged Compressor Wheel**

Figure 2.1 shows the 2 L engine turbocharger with a badly damaged compressor impeller due to heavy volute rubs. Extensive wear marks may also be observed on the bearings.

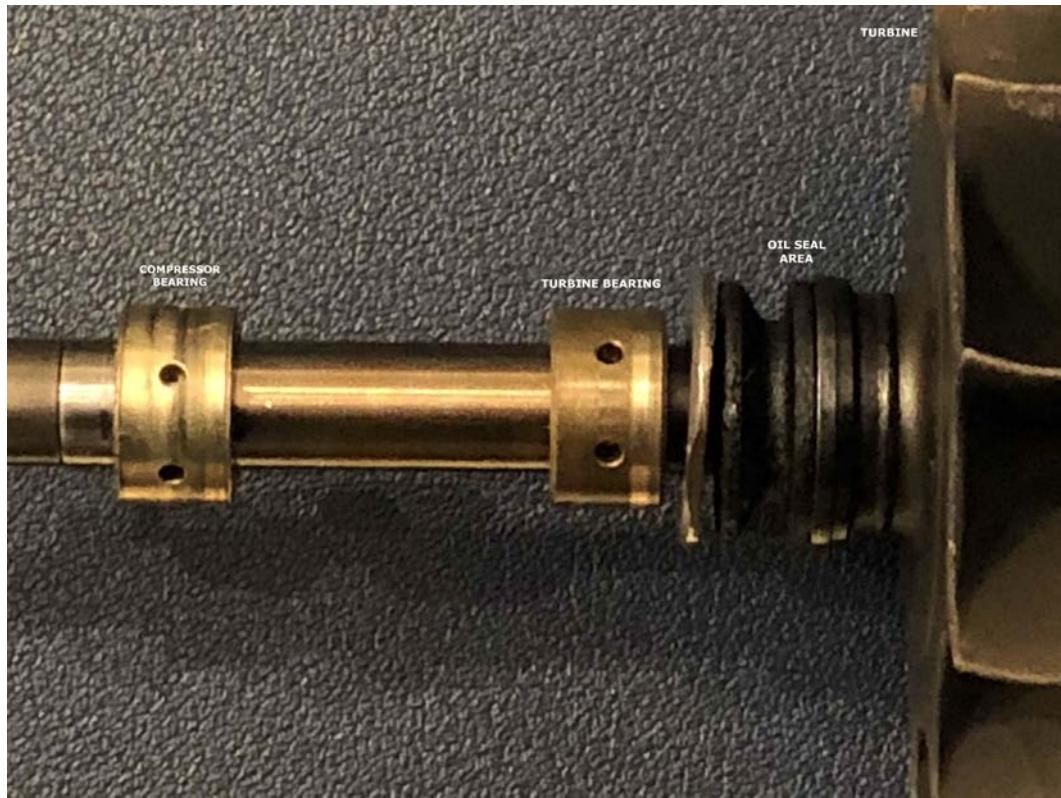
**Fig. 2.2 Closeup of Turbine, Floating Bush Bearings and Oil Seal Area**

Figure 2.2 shows a closeup of the floating bush bearings and heavy coking in the turbine oil seal area. The heavy narrow band wear ring on the turbine side bearing is a strong indicator that the turbocharger was precessing in a conical whirl orbit. This conical whirling tendency of all turbochargers will be discussed in further detail in the next section on analysis. Measurements of the compressor end bearing clearance showed a large increase in internal bearing clearance due to wear. This large increase in clearance allowed the compressor wheel to rub on the volute.

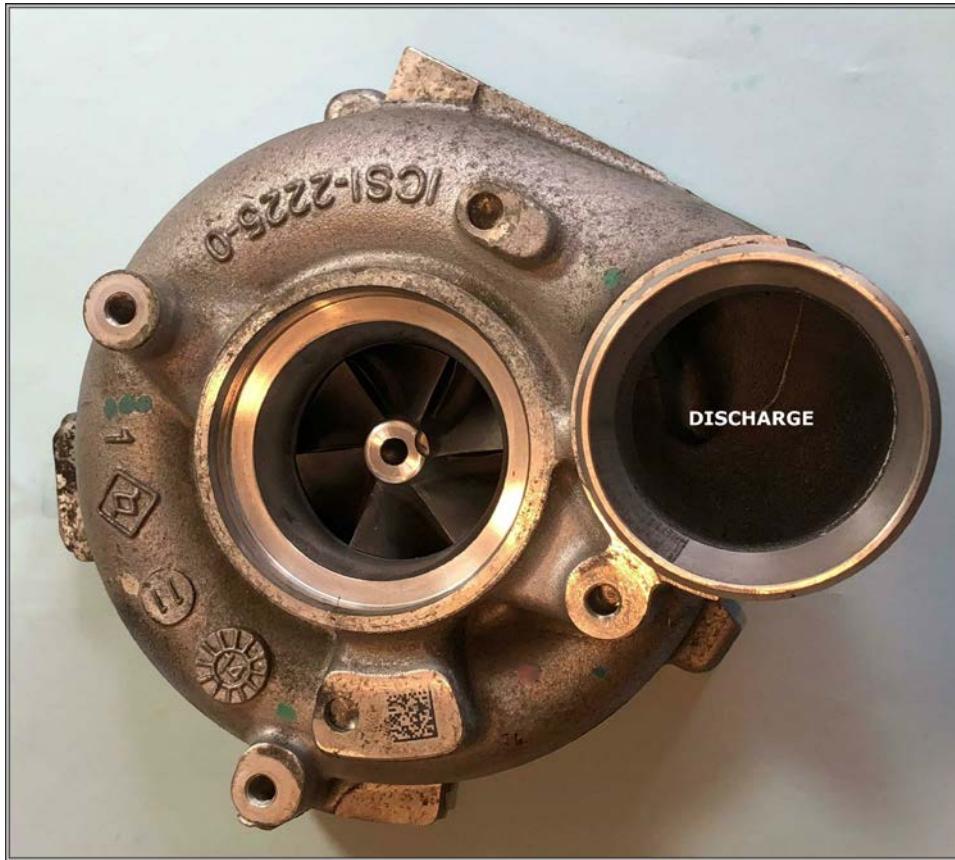
Fig. 2.3 Turbo Inlet Showing Compressor and Air Discharge Passage

Figures 2.3 and 2.4 represent the front and back view of the compressor volute. In Figure 2.4, it is clearly seen that the impeller has caused heavy rub marks on the volute casing. When heavy rubbing occurs with the compressor wheel against the volute casing, the torque on the turbine power wheel may cause the turbine shaft to snap as clearly seen in Fig 2.5.

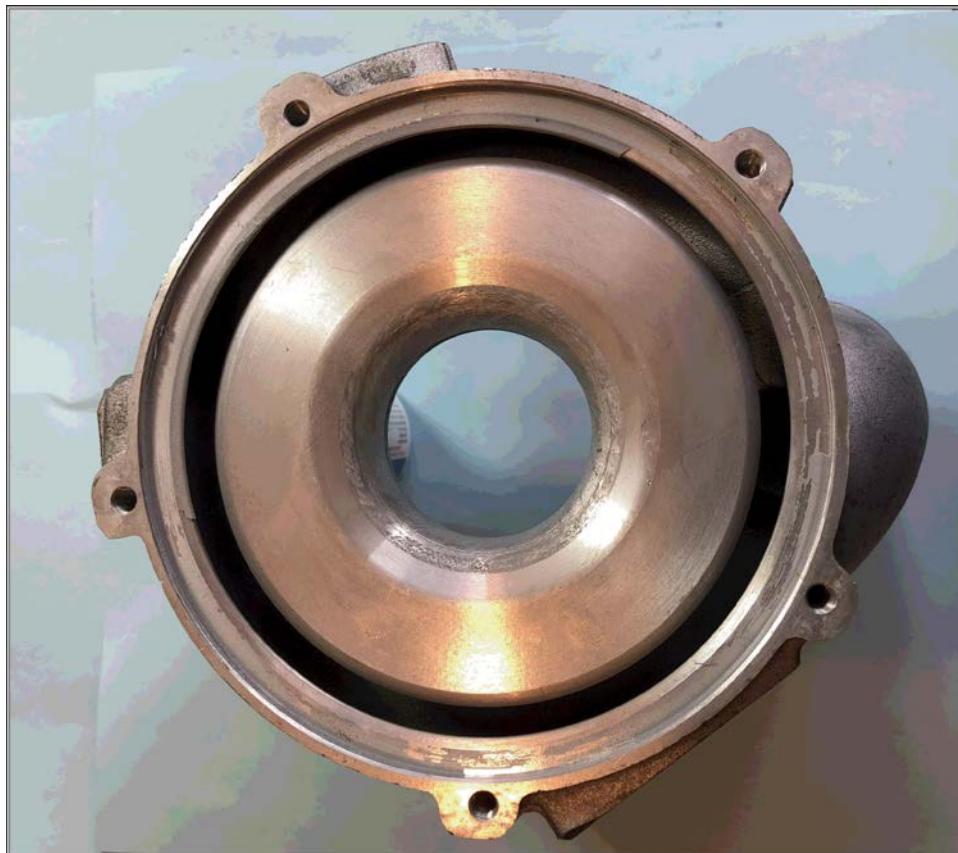
Fig. 2.4 Compressor Volute Showing Heavy Impeller Wear Marks

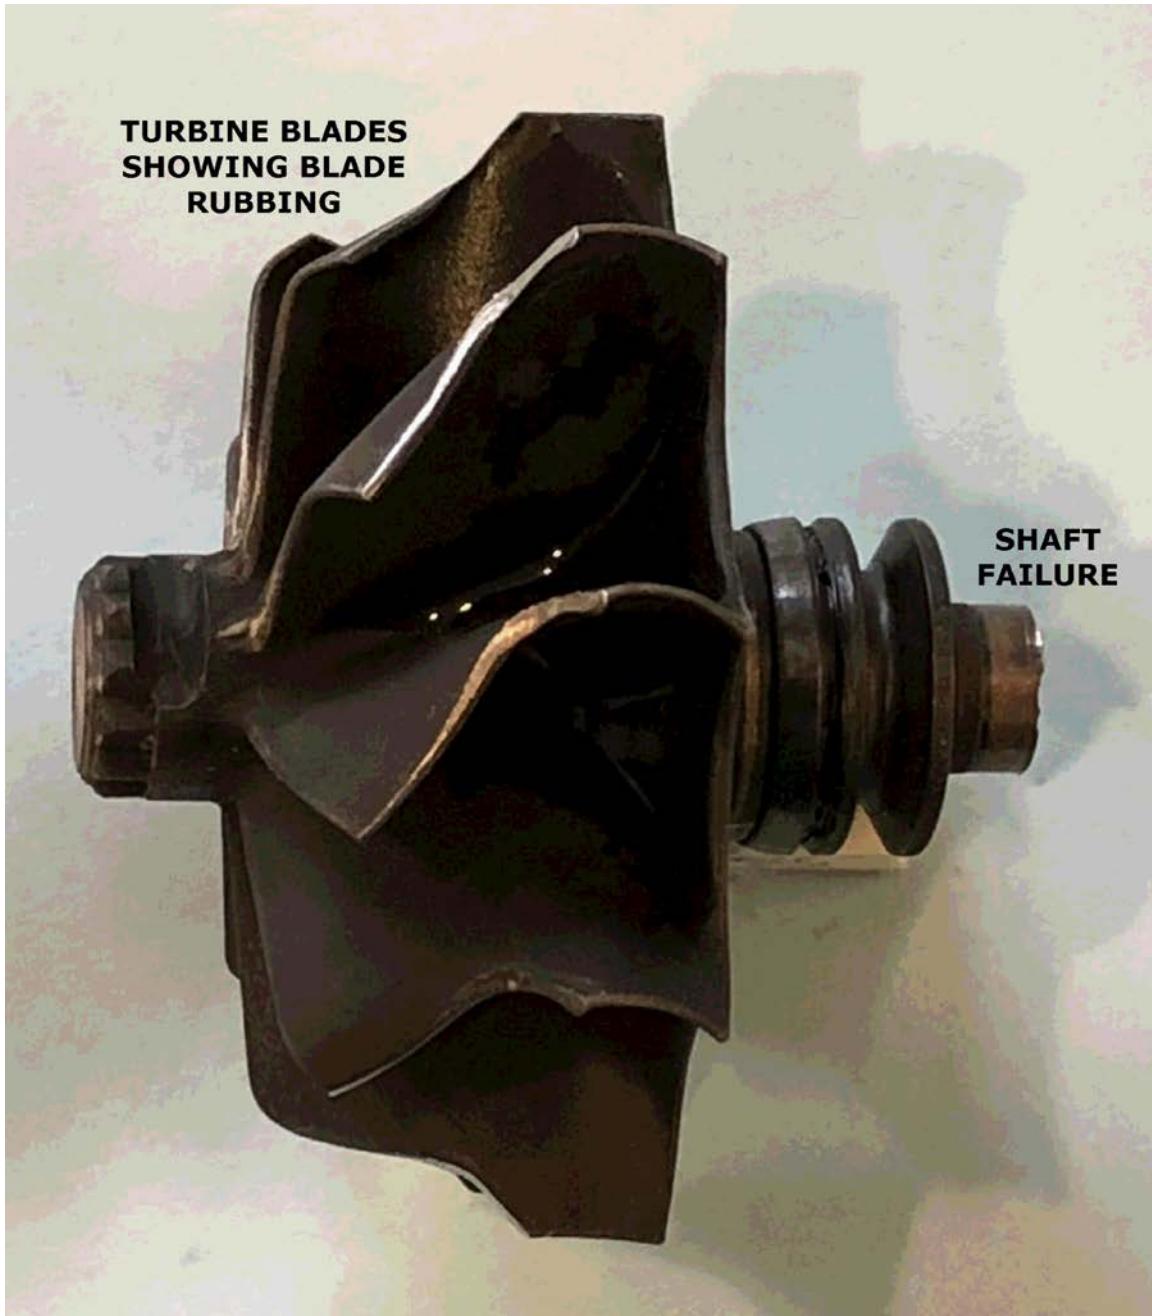
**Fig. 2.5 Power Turbine Showing Blade Rubs and Shaft Failure**

The high rub marks on the turbine blades may actually have occurred after the compressor wheel has had a heavy rub and the turbine shaft has sheared. The power turbine rubbing may have occurred after the shaft failure at the turbine location. This is very common with the occurrence of heavy compressor rubs. The shaft at the turbine location shears first and then the heavy rubbing on the turbine wheel is encountered.

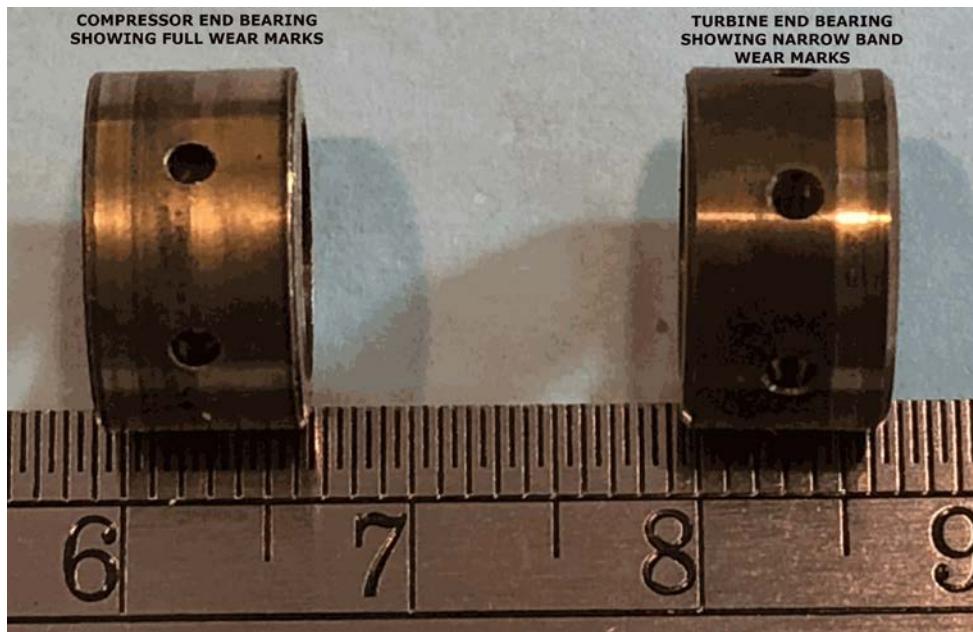
Fig. 2.6 Comparison of Compressor and Turbine Bush Bearings

The clearances on the floating bush bearings should normally be less than one mil. Measurement of the shaft and internal diameter of the compressor bearing has shown that the clearance has been enlarged to over 10 mils, allowing the impeller to impact the volute.

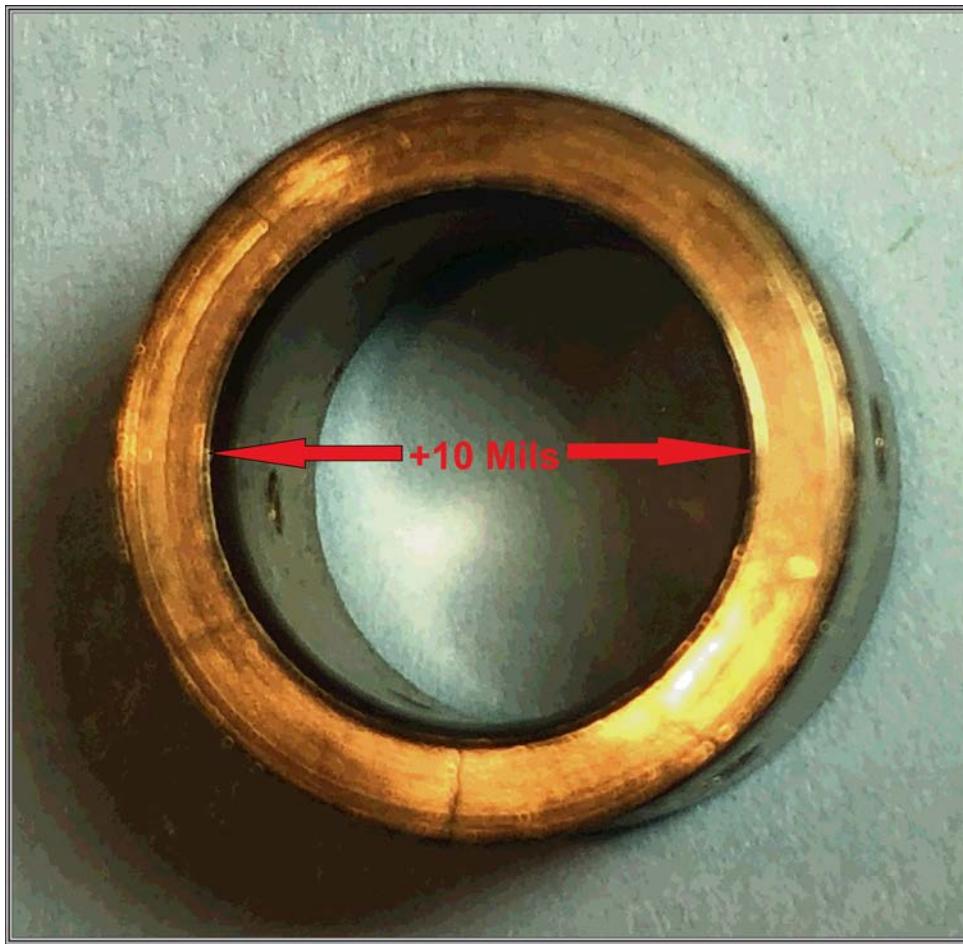
Fig. 2.7 Compressor Bushing Showing Enlarged Bearing by 10 Mils

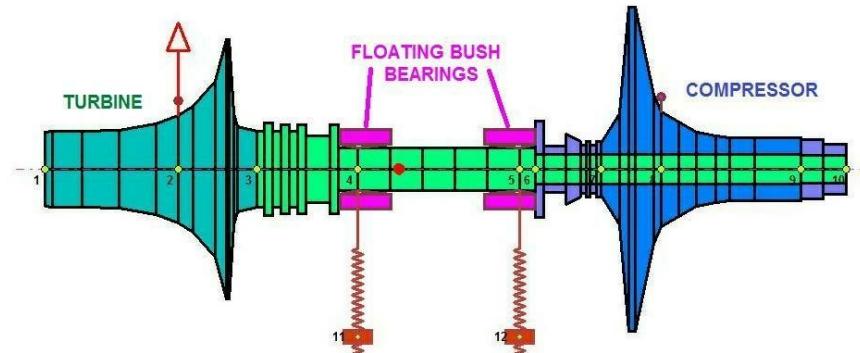
Fig. 3.1 2 L 4 Cylinder Turbocharger Model

Figure 3.1 represents a computer simulation model of the small turbochargers designed for two liter four-cylinder engines. The turbocharger is supported by two bronze floating bushing bearings which are slightly less than one half of an inch in diameter and slightly wider than one quarter of an inch. These turbochargers are designed to operate at speeds of over 200,000 RPM.

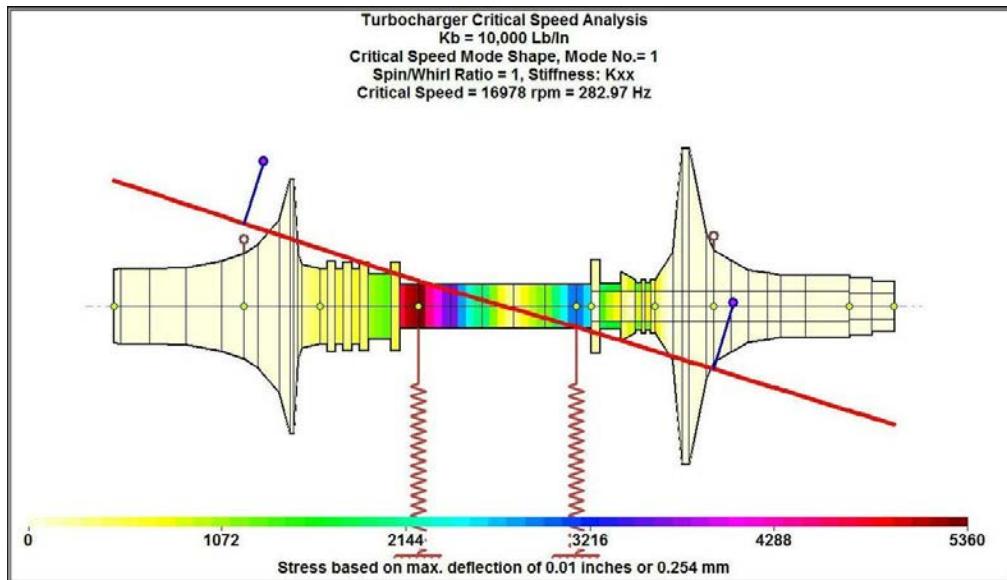
Fig. 3.2 1<sup>st</sup> Critical Speed at 283 Hz With Assumed Kb = 10,000Lb/In

Figure 3.2 represent the predicted turbocharger first critical speed based on an assumed bearing stiffness value of Kb = 10,000 Lb/In. This mode is essentially a rigid body mode in which the turbine and compressor wheels move out of phase. The exact frequency is a function of the actual bearing stiffnesses and may vary due to the actual bearing values of the floating bush bearings and rotor unbalance.

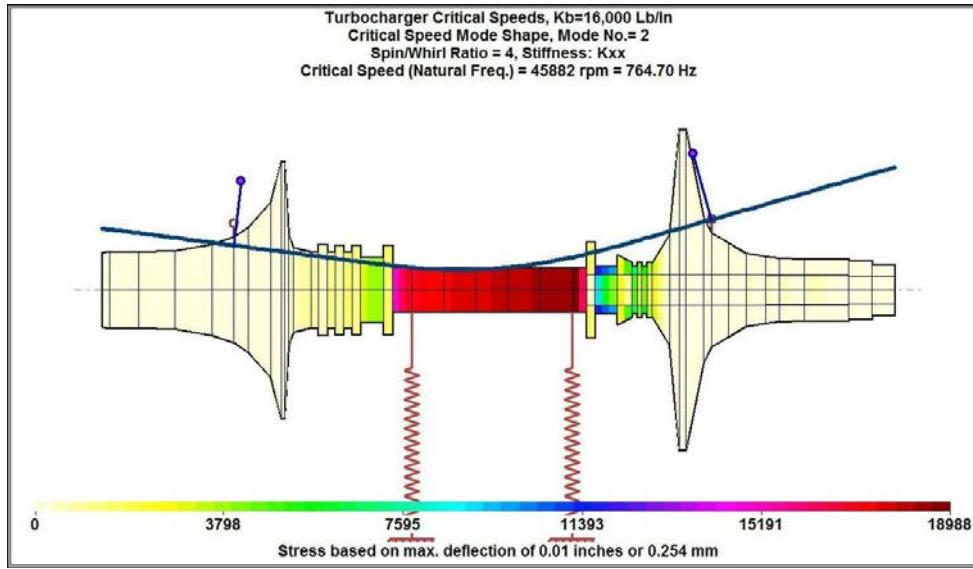
**Fig. 3.3 2<sup>ND</sup> Turbocharger Critical Speed at 765 Hz**

Figure 3.3 represents the turbocharger second critical speed under the assumed bearing stiffness values of  $K_b = 1e5$  Lb/in. The exact value of this mode is determined by the bearing coefficients at the operating speed of 220,000 RPM. With floating bushing bearings, both the first and second modes may be excited at running speed. The instability in the second mode is of concern as the turbo amplitude is much higher at the compressor location leading to increased bearing wear and rubbing of the compressor on the volute.

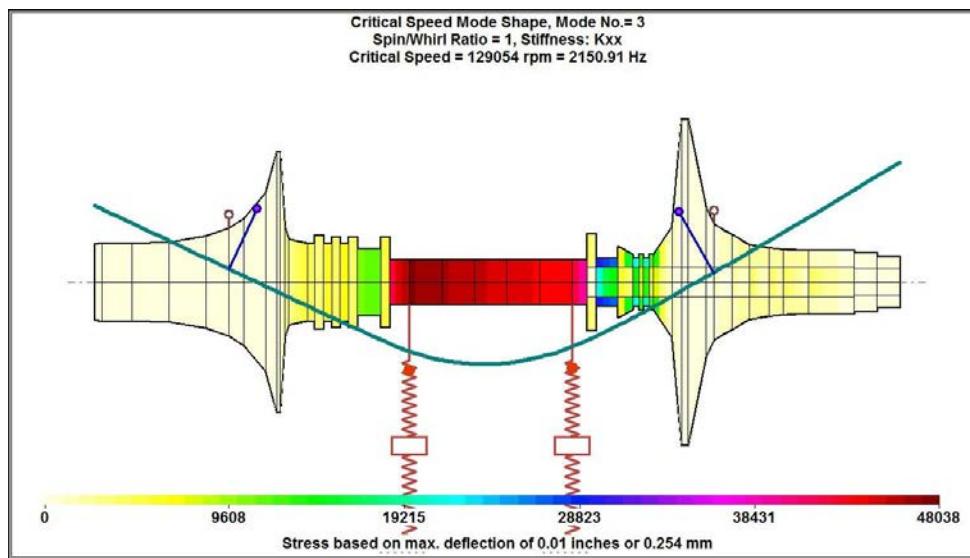
**Fig. 3.4 3<sup>rd</sup> Critical Speed Bending Mode at 129,00 RPM  
(2150 Hz)**

Figure 3.4 represents the third turbo critical speed which is a bending mode. In proper turbocharger design, the bending mode should be above the operating speed range, and should not be encountered in the speed range. Floating bush bearing damping is very ineffective in controlling the third bending critical speed.

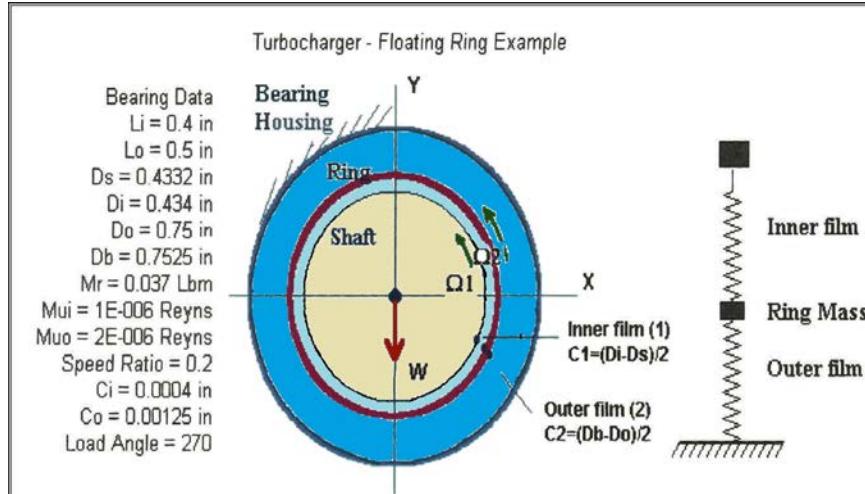
Fig. 3.5 Schematic Diagram of the Floating Bush Bearing

Figure 3.5 represents a schematic diagram of a floating bush bearing. In the design of the floating bush bearing, the center inner clearance is kept at a much tighter value than the outer clearance. The operation of a floating ring bearing is such that the ring spends at about a rate of 20% of shaft speed due to the internal friction. The original concept of the floating ring bearing developed by General Motors in the 1930s was to reduce frictional losses. The plain journal bearing is inherently unstable even at very low speeds. With the floating ring bearing, the system is still unstable but the motion of the ring produces nonlinear stiffness and damping components which allow for controlled limit cycle motion.

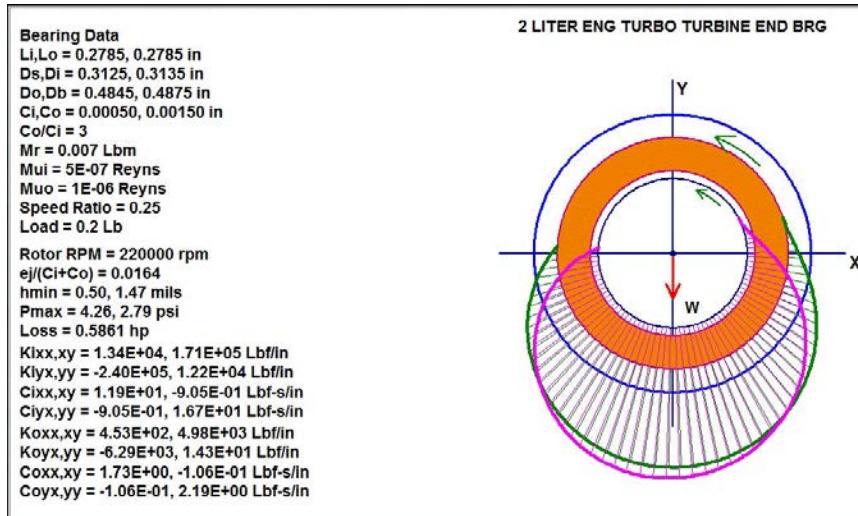
Fig. 3.6 Stiffness And Damping Characteristics of a Floating Ring Bearing at 220,000 RPM

Figure 3.6 represent the stiffness and damping characteristics of the compressor side floating ring bearing at 220,000 RPM. Because the compressor side bearing is so lightly loaded, the bearing has low direct stiffness but very high cross coupling stiffness which adds to the instability characteristics.

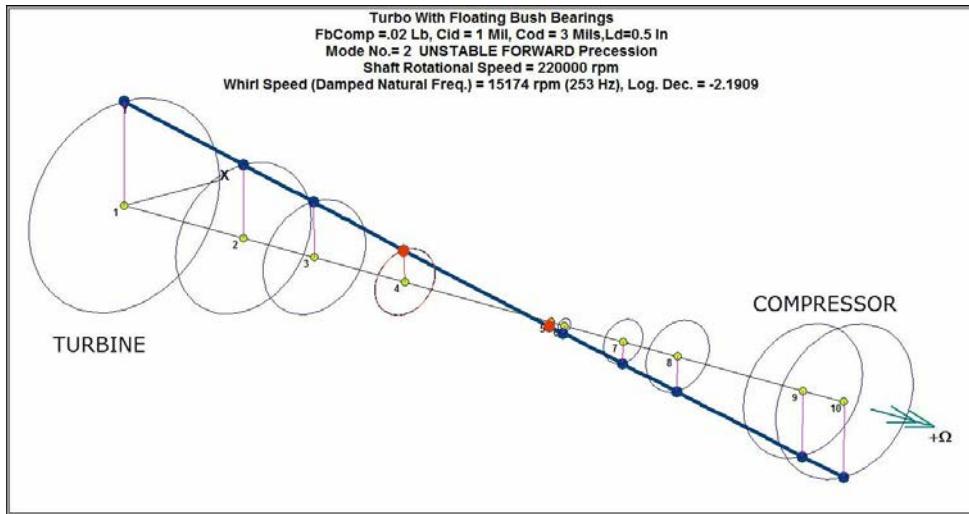
**Fig. 3.7 Unstable Conical Whirl Mode at a Frequency of 253 Hz**

Figure 3.7 represents the first conical whirl mode of the turbocharger at a frequency of 253 Hz. This is basically a rigid body mode in which the turbine and compressor motion are moved out of phase. This conical whirl motion can cause the impeller to rub against the volute causing turbocharger failure. All turbochargers with floating bush bearings exhibit this type of whirl motion. This distinct frequency may be detected on an engine using a frequency analyzer. It is a very low frequency compared to the frequency of running speed.

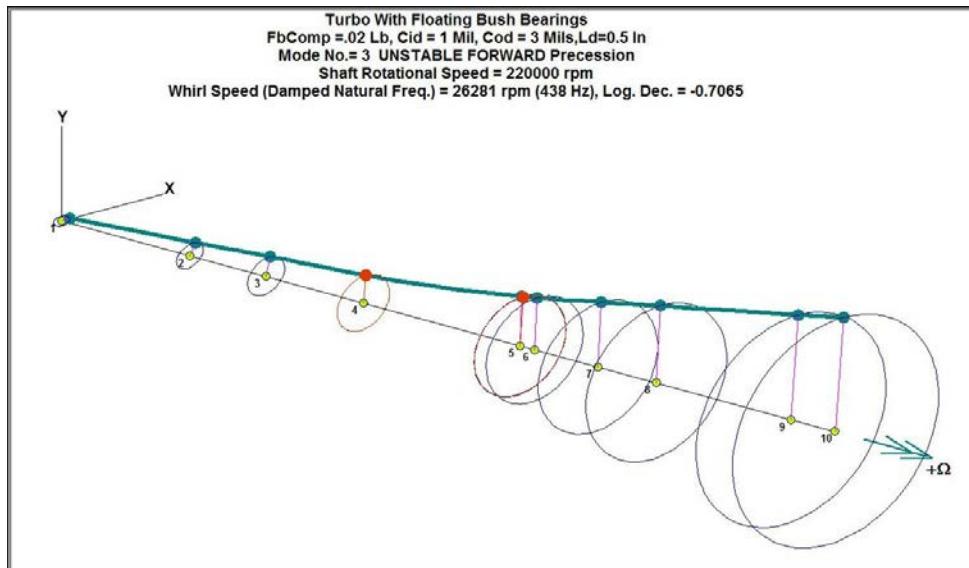
**Fig. 3.8 Second Whirl Mode with Large Compressor Motion  
At a Whirl Frequency of 453 Hz**

Figure 3.8 represents the second unstable whirl mode that may be encountered in the turbocharger. In this particular whirl mode, there is large amplitude of motion at the compressor location. The turbocharger vibration spectrum, on increase in speed, may exhibit one or both of these frequencies. This higher frequency whirl mode may also induce further wearing of the compressor side bushing bearing. These fundamental self-excited unstable whirl frequencies are inherent with all floating bush bearing turbocharger designs and can not be avoided.

What is of interest to observe is that in the excitation of the second whirl mode, the largest amplitude of motion occurs at the compressor end. This is due to the heavier weight of the turbine. Examination of the wear on the compressor bearings showed excessive wear that was not apparent in the turbine bearings. The design of the compressor bearing actually needs to be larger in order to carry the increased loading.

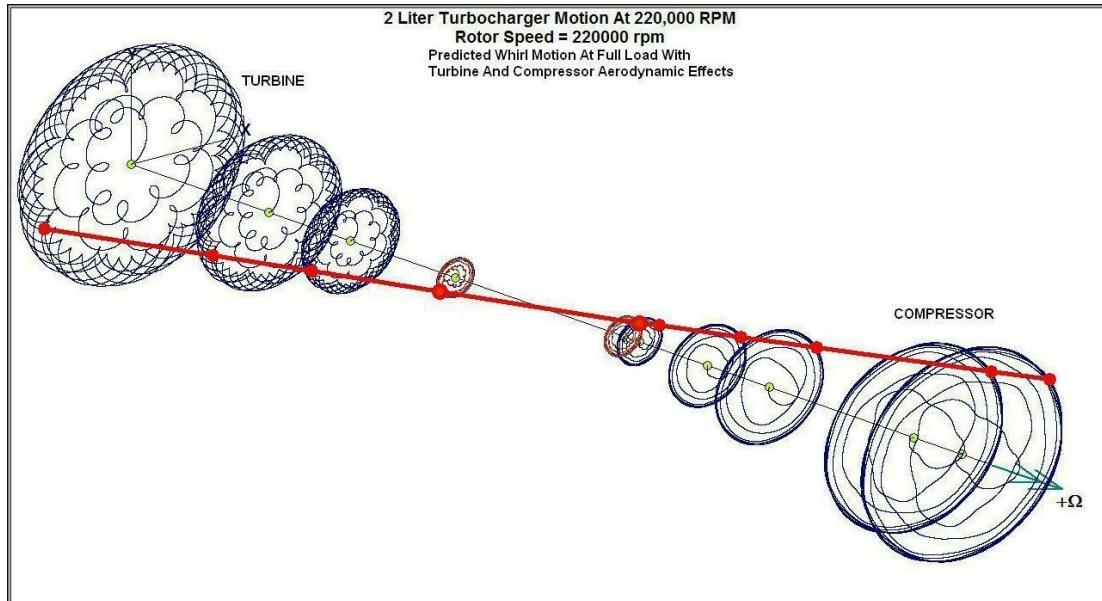
**Fig. 3.9 Turbocharger Time Transient Analysis With Added Compressor and Turbine Alford Forces and Turbine Unbalance**

Figure 3.9 represents the time transient analysis of the turbocharger at 220,000 RPM with the addition of the aerodynamic Alford forces acting at both the compressor and turbine locations. A small amount of unbalance has been added to the turbine location. Instability experienced in turbochargers is not solely due to the floating bush bearings. Even turbochargers operating with rolling element bearings may experience unstable self excited whirl motion due to the added effect of the Alford forces acting on the turbine and compressor locations.

The violent turbocharger motion as depicted in Figure 3.9 may be generated by operating the turbocharger at full power. When this occurs, there is a distinct tone or howl that may be observed admitted from the turbocharger. In this case the tone is similar to the pitch of A4# of the keyboard. Each turbocharger has its own distinct signature and frequency content which can be recorded with an iPhone 8 or 10 using the appropriate APPLE app for a frequency analyzer or for a decibel meter.

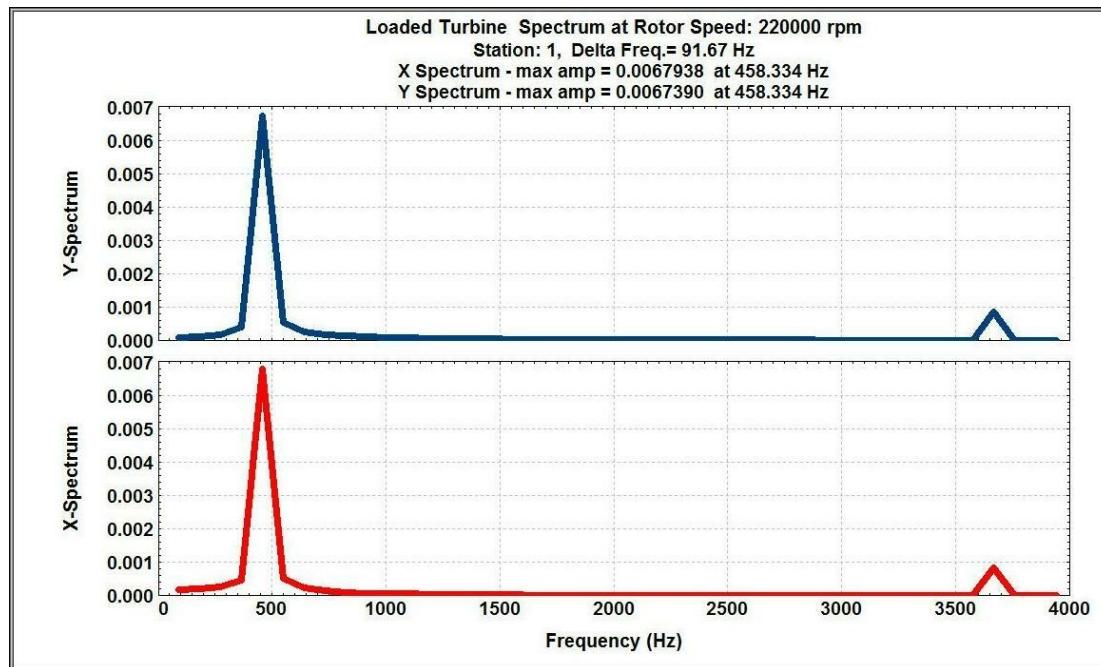
**Fig. 3.10 FFT Frequency Spectrum Analysis of Turbocharger Vibration**

These aerodynamic forces were first described by Joel Alford of GE Gas Turbine Division and are now referred to as Alford forces. He showed that when turbines and compressors operate in an eccentric fashion, the change in efficiency around the turbine or compressor wheel will cause cross coupling forces to act on the system.

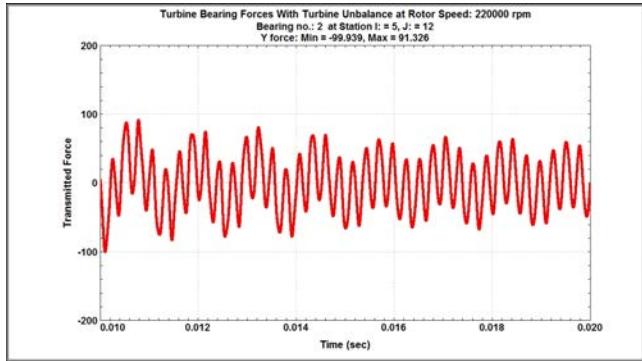
Figure 3.11 shows the turbine bearing forces transmitted over 40 cycles of the shaft motion. The turbine bearing forces show an initial peak response of 100 pounds. This peak response attenuates to a value of approximately 60 pounds of force transmitted after 30 cycles of shaft motion. The undulation of the vibration spectrum is due to the low-frequency whirling of the turbocharger. Although the turbocharger is unstable with subsynchronous whirling, the motion is bounded due to the nonlinear bearing forces. This effect is referred to as limit cycle whirling.

**Fig. 3.11** Turbine Bearing Forces Transmitted With 0.01 Oz-in Turbine Unbalance

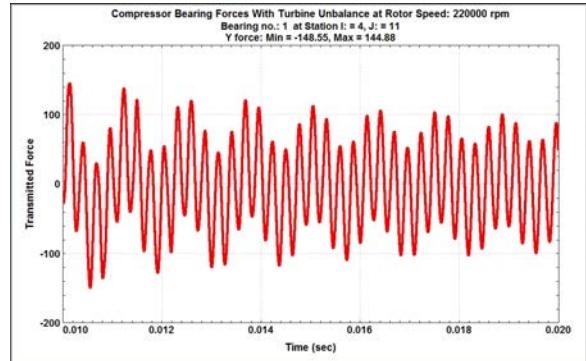
**Fig. 3.12** Compressor Bearing Forces With 0.01 Oz-in Turbine Unbalance

Figure 3.12 represents the compressor bearing forces transmitted due to the turbine unbalance. The initial transient force due to the suddenly applied unbalance is 140 Lb. After 30 cycles of shaft motion the maximum compressor bearing load attenuates to 100 pounds. Thus we see that unbalance at the turbine impeller actually causes higher forces to be transmitted to the compressor floating bush bearing.

This characteristic of turbine unbalance causing higher forces transmitted to the compressor bearing is characteristic of most turbochargers. This is due to the fact that the turbine wheel is considerably heavier than the compressor impeller. This causes the turbine disk to act as a node point and the unbalance force on the turbine is magnified at the compressor bearing location. This effect adds to the wearing experienced by the compressor bearing. An increase in the compressor bearing clearance makes the system even more unstable.

One of the other problems encountered with these turbochargers is a change of balance during operation. This in particular occurs with the turbine which can become unbalanced due to exhaust deposits. Unbalance of the turbine actually causes larger forces to be exerted on the compressor bearing as shown in Figure 3.12

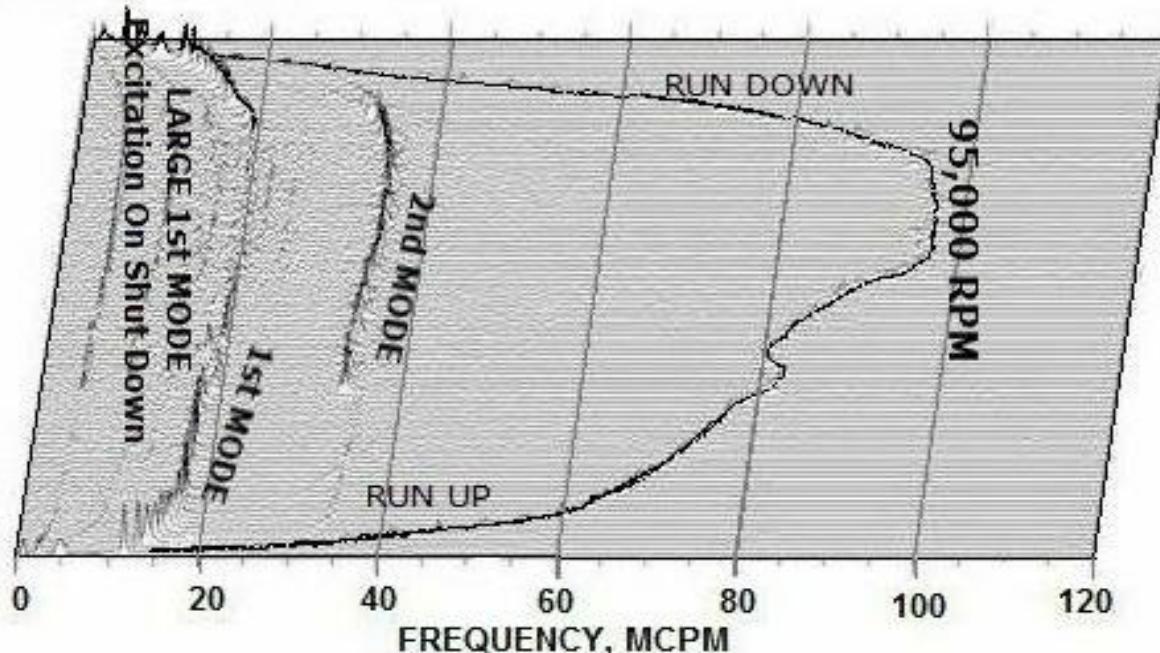
Figure 4.1 shows the turbo vibration spectrum during a 4-minute run up and run down of the 3.9 L diesel turbo. The frequency is presented in cycles per minute (CPM) rather than the normal use of cycles per sec (Hz).

**Fig. 4.1 Experimental Vibration Spectrum Of A Diesel Engine Turbocharger On Run Up And Run Down Showing Unstable Whirl Modes With Floating Bush Bearings**

As the diesel engine starts up, a peak amplitude occurs at approximately 12,000 RPM. This peak represents the first critical speed of the turbocharger, which is a conical rotor mode with the compressor and turbine disks whirling out of phase. As the rotor speed is increased to approximately 60,000 RPM, the first whirl mode dies out.

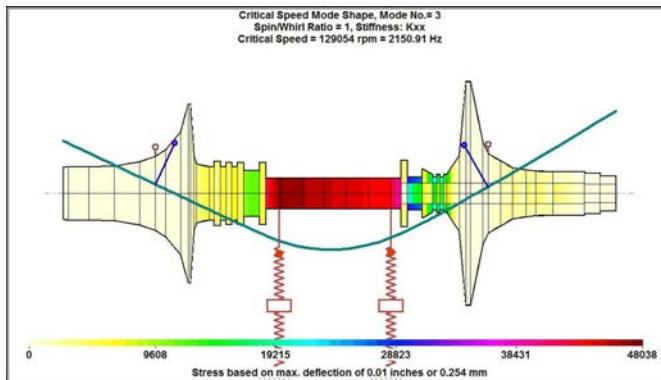
Encountering the third bending mode in the operating speed range can result in significant high synchronous vibration amplitudes at both the turbine and compressor wheels.

**Fig.4.3 Turbocharger Undamped Bending Critical Speed (3<sup>rd</sup> mode)**

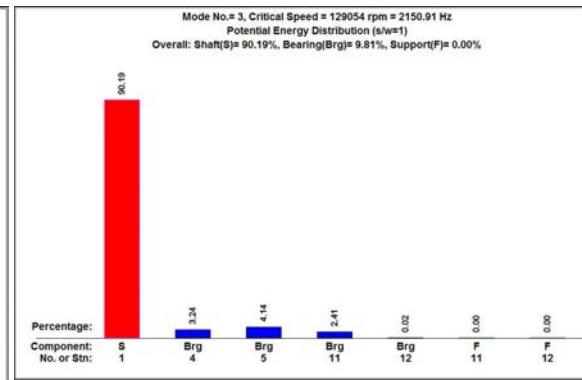
**Fig. 4.4 3<sup>rd</sup> Mode Strain Energy Showing 90% Energy in Bending**

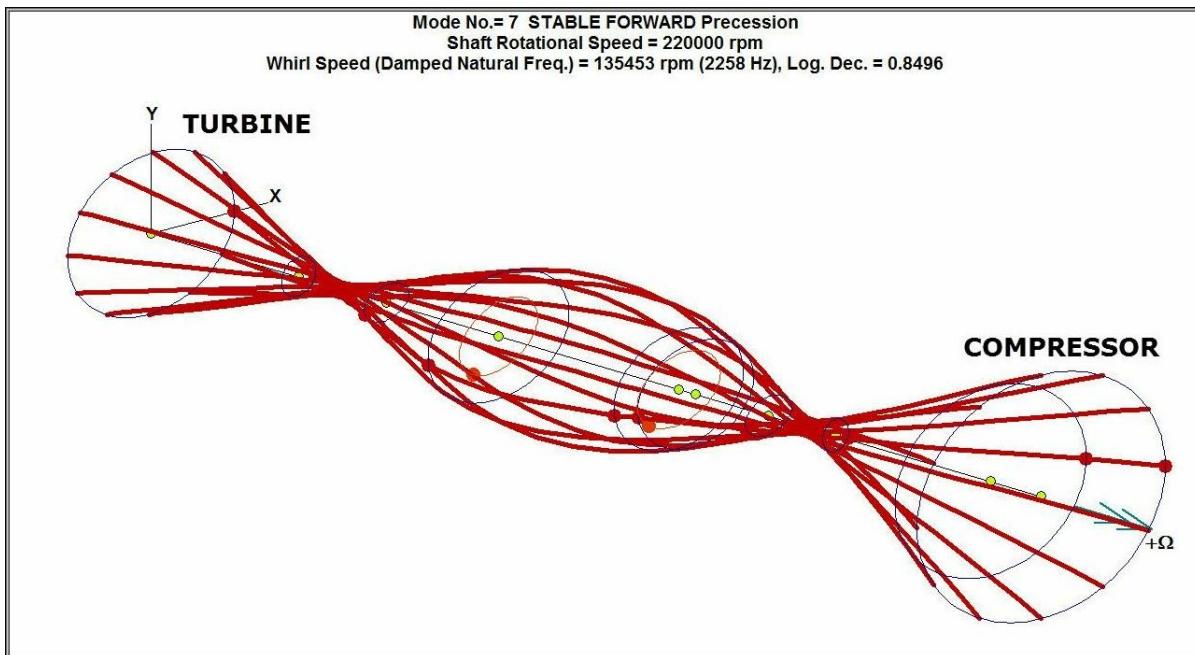
**Fig. 4.5 3-Dimensional Bending Mode Including Bearing Stiffness and Damping Coefficients At 135,453 CPM**

When damping is included, the third bending mode is slightly increased to 135,453 CPM. This low frequency is due to the slender turbocharger shaft. This bending mode lies well within the operating speed range of the turbo. This is not a desirable feature to have and is not recommended for good design. The problem is that turbomachinery designers are usually more concerned with turbocharger efficiency and performance rather than the rotor dynamics of the system. As a result we have a turbo design with too small a shaft diameter and inadequate fluid film bearings.

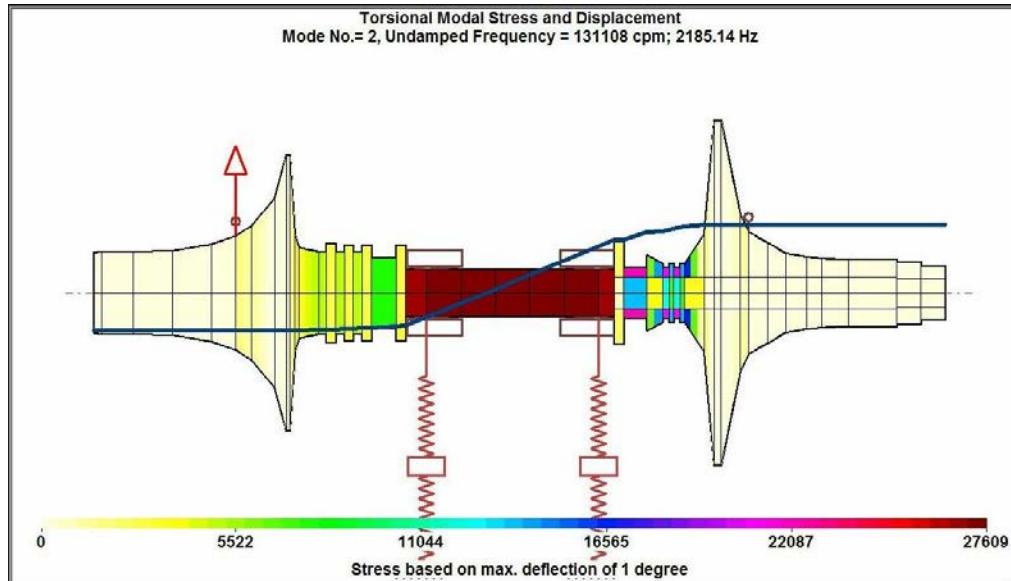
Figure 4.6 represents the first torsional mode of the turbocharger which is at a frequency of 131,108 CPM. It is of great concern to have the confluence of the turbocharger bending mode correspond with the first torsional mode. In the first torsional mode, the wheels are twisting out of phase to each other. In the bending mode, the turbine and compressor wheels are tilted and hence can rub and come in contact with the volute or casing. When this occurs, the torsional mode can also be excited, causing significant turbocharger damage.

**Fig. 4.6 1st Torsional Mode at 131,108 CPM**

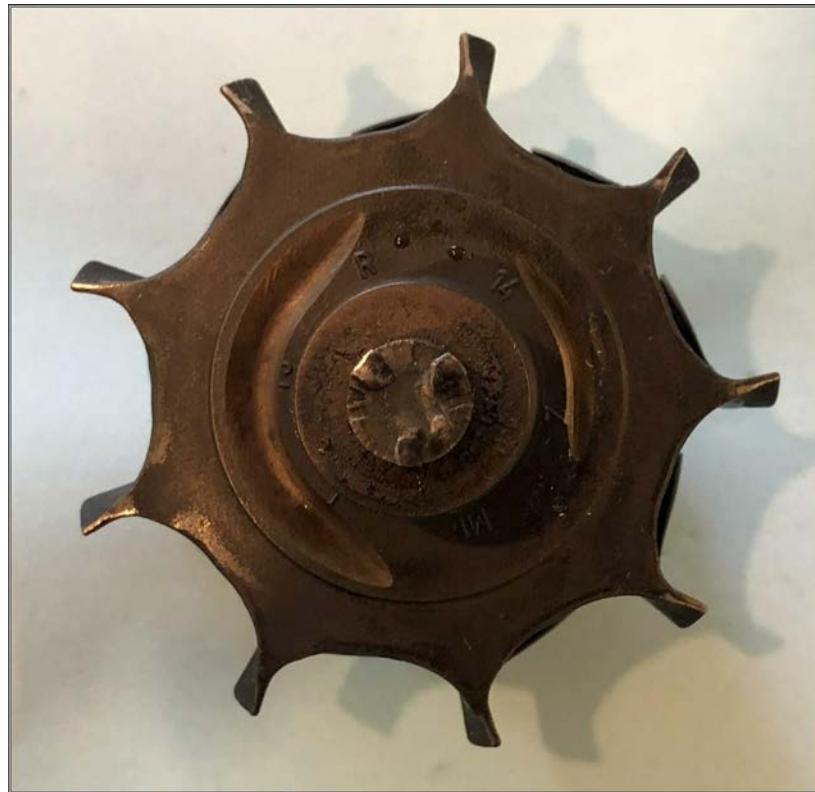
Figure 4.7 shows the back side of the failed turbine. Figure 4.8 is a close-up showing the failed shaft. The shaft failure is similar to shaft torsional failures caused by suddenly applied torques.

**Fig. 4.7 Rear View of Failed Turbocharger Turbine**
