## Review and Failure Analysis of Three 4 Cylinder Engine Turbochargers *And Methods on How to Extend Turbocharger Life*

Edgar J. Gunter, PhD

# 2 Liter Engine Turbocharger Failure Analysis

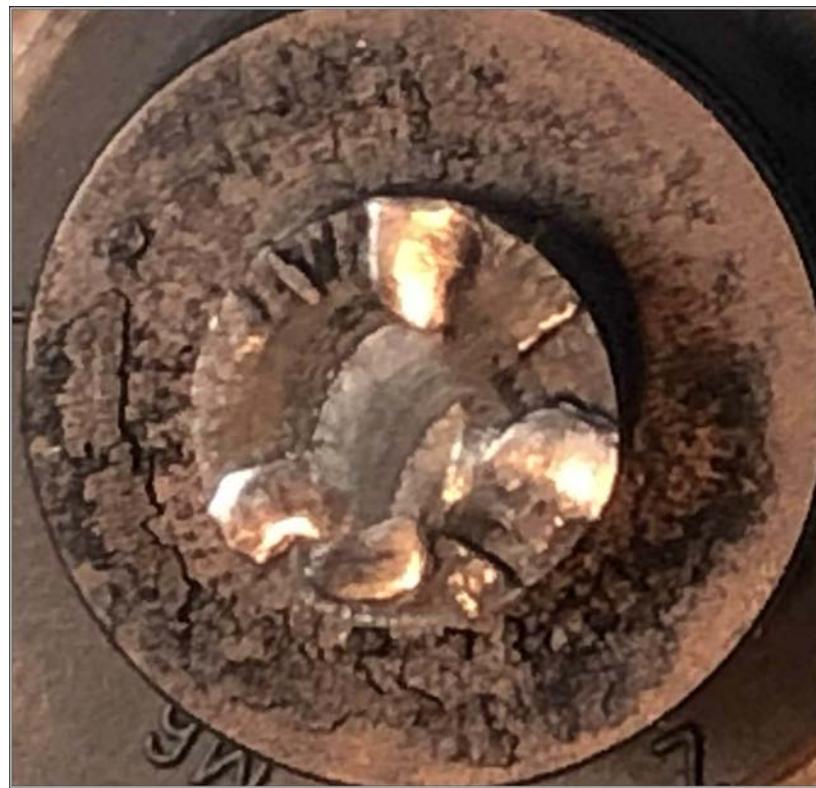
Figure 4.7 shows the back side of the failed turbine. Figure 4.8 is a close-up showing the failed shaft. The shaft failure is similar to shaft torsional failures caused by suddenly applied torques.

**Fig. 4.8 Close Up Turbine Shaft Showing Shear Failure**

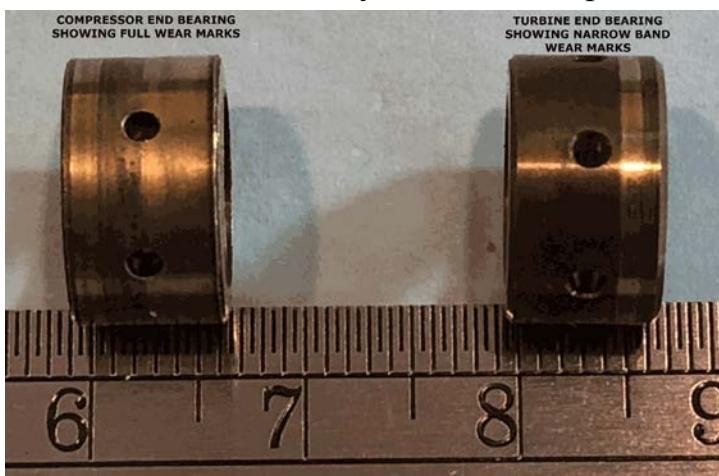
The turbocharger compressor end bearing is too narrow to carry the dynamical loading and it is also insufficiently lubricated to prevent internal wearing.

**Fig. 5.2 Comparison of Compressor and Turbine Floating Bush bearings**

It is recommended that the compressor end bearing be doubled in length in order to carry the required dynamical loading. Such a design change may be resisted by the turbocharger manufacturer as this would increase bearing friction losses and would increase turbocharger lag. The other recommendation is that an external central groove be added to the compressor end bearing in order to provide better lubrication for both the outer and inner bearing surfaces.

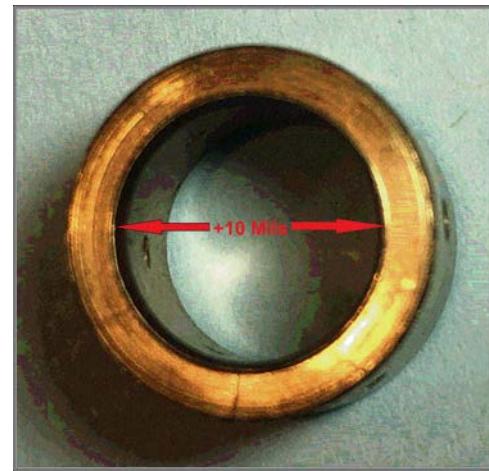
**Fig. 5.3 Compressor Bearing Showing 10 Mil Clearance**
