ROTOR BEARING AND SHAFT DYNAMICS REDESIGN OF A DOUBLE-OVERHUNG TURBOEXPANDER FOR RELIABILITY IMPROVEMENT

ABSTRACT

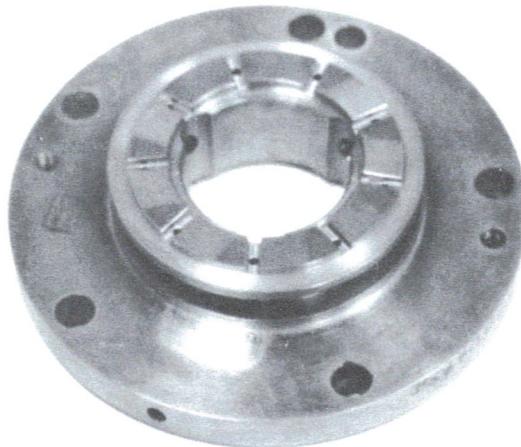
Figure 5. Photograph of Original Compressor-End Combination Tapered Land Thrust and Three-Lobe Journal Bearing.

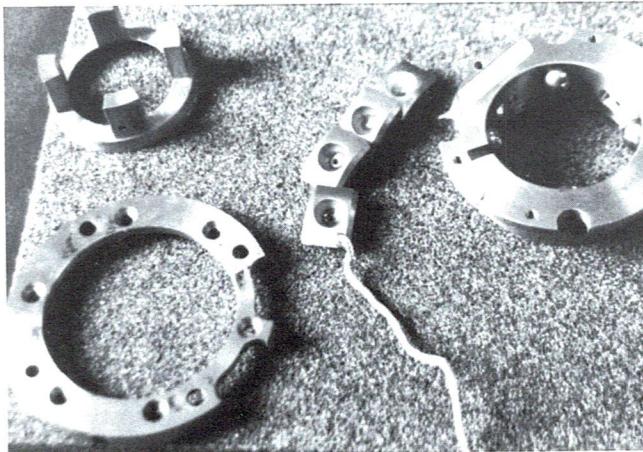
Figure 30. Photograph of New Phase One Expander-End, Four-shoe Tilting Pad Journal Bearing Retrofit Showing Spherical Pivots.
